# *Sherlock Homes Inspection & Appraisal, LLC*

## Property Inspection Report

1234 Inspection Blvd, Mead, CO 80542  
Inspection prepared for: John Doe & Jane Doe  
Real Estate Agent: Jimmy Doe - Resident Realty

Date of Inspection: 1/26/2017 Time: 11:00 a.m.  
Age of Home: 8 months Size: 4865 sq. ft.  
Weather: Cloudy

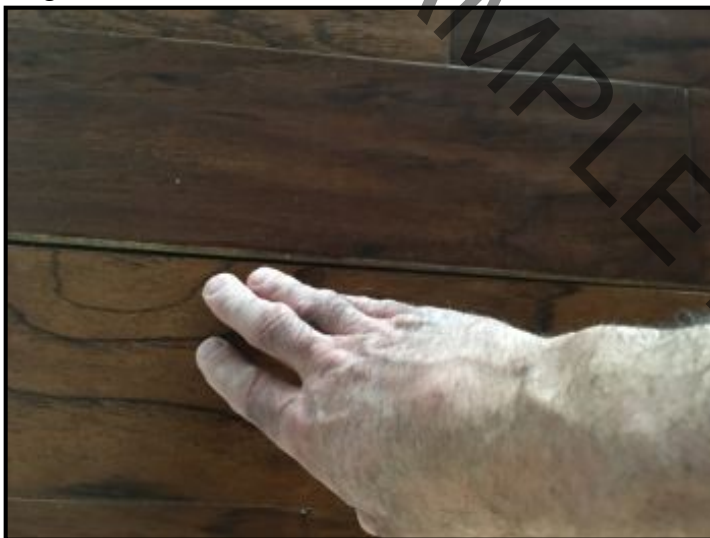
Gap in floor creates flex / bounce on adjacent board.

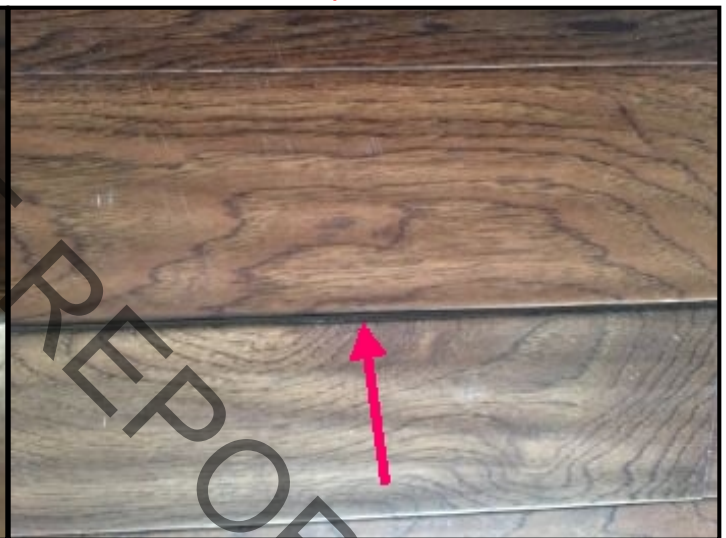
Gap in floor joint.

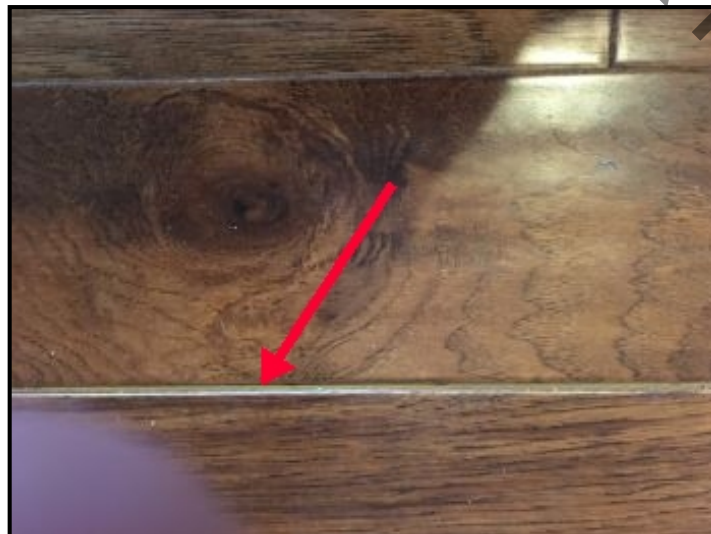
Another gap in the floor board joint.

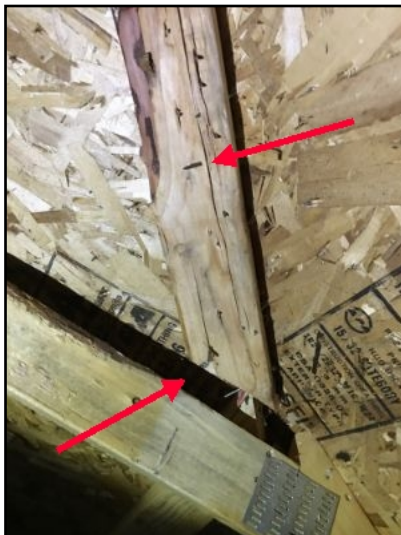
There is some poor framing and cracked lumber used in the attic for the hip support

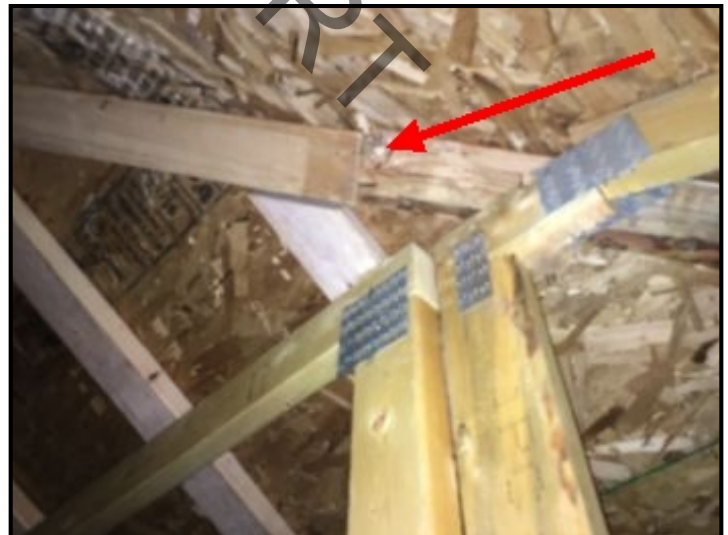
Poor framing practices, although this is not necessarily a structural issue it is just not good professional quality framing.

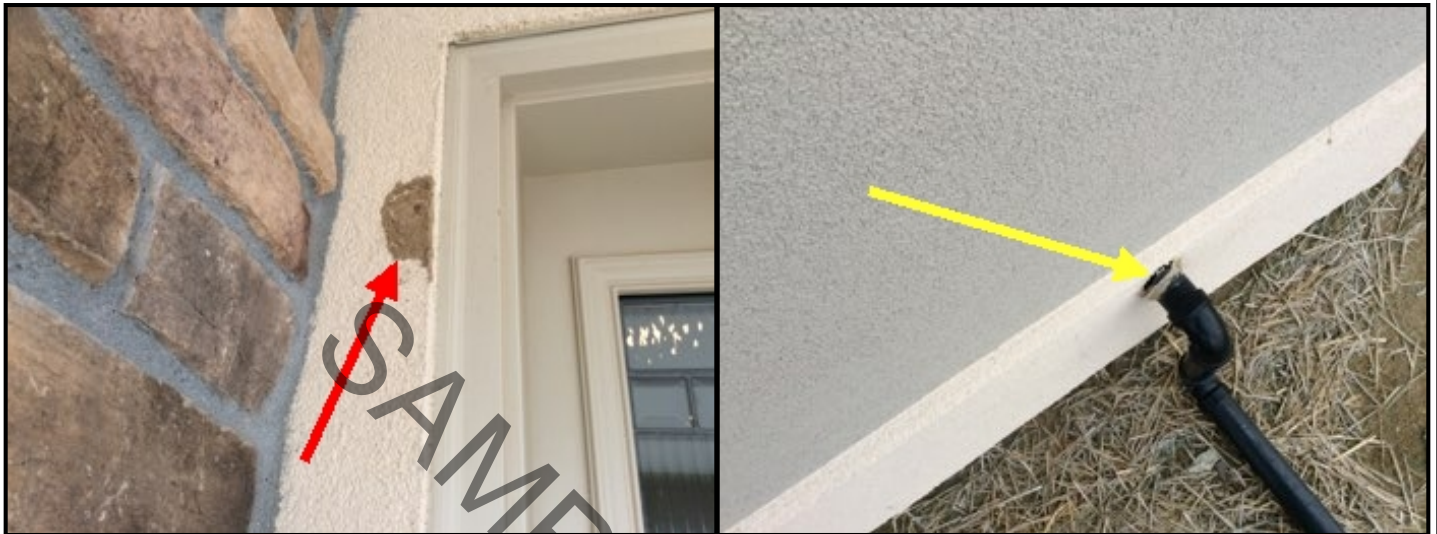
This area of Stucco at the front door appears to have been repaired improperly.

The sump pump drainage pipe needs resealed where it exits the house.

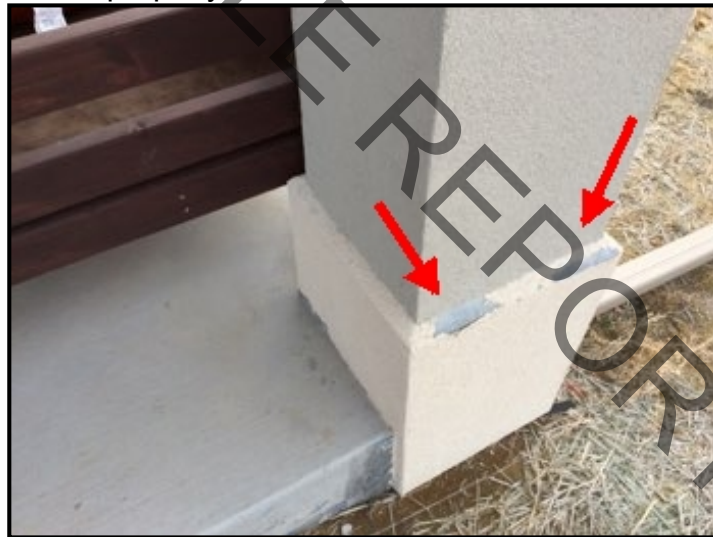
I would recommend touching up the paint in areas like this.

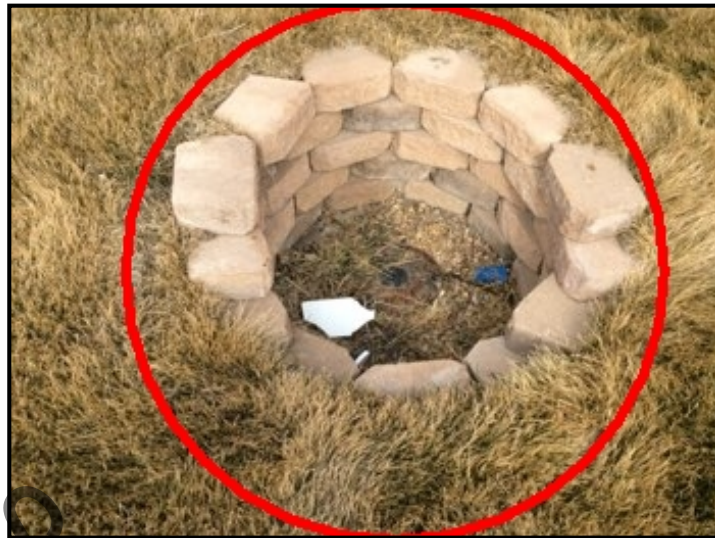
Grounds		
Page 45 Item: 2	Grading	<ul style="list-style-type: none"> <li>• The meter pit in the front yard is poorly planned and a safety hazard. There are extensions manufactured for the meter pits that can be installed and bring the meter lid up to grade.</li> </ul>

This meter is a safety hazard and should be repaired by a professional contractor as soon as possible. The meter can be raised with a sleeve and dirt filled in around it, there is no reason to have a trip, fall hazard such as this.

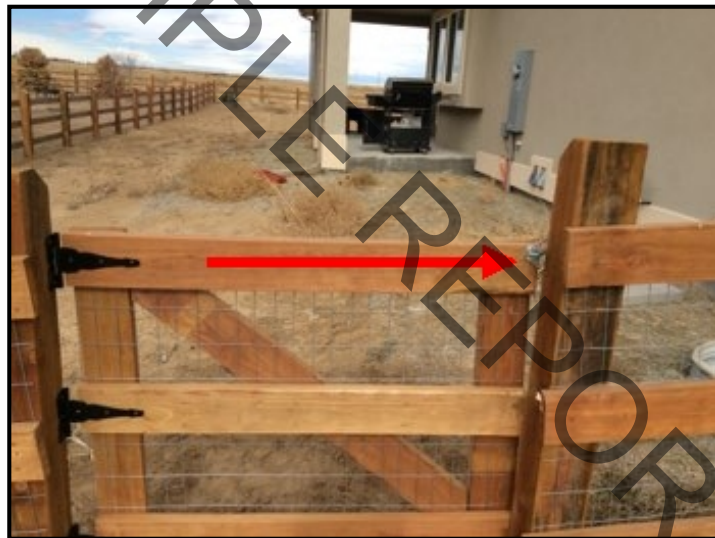
This gate sticks slightly and can be adjusted for easier opening

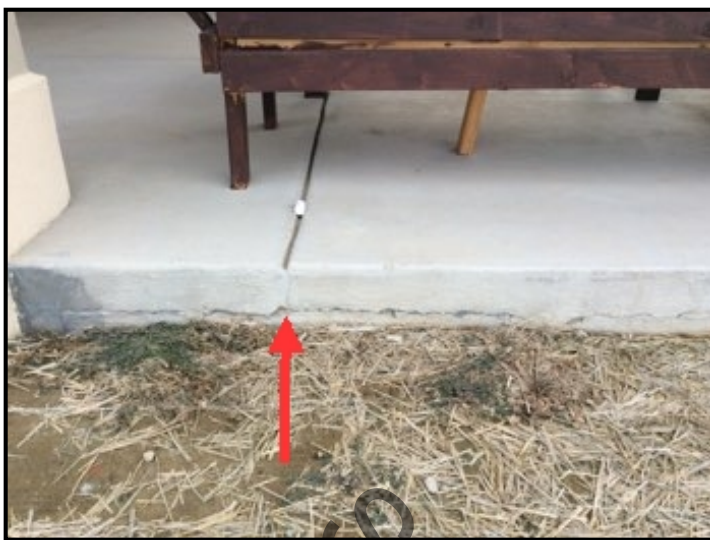
Page 48 Item: 15 Patio Enclosure • There is a synonymous crack around 2 sides of the back concrete patio that is of some concern. I would recommend a licensed contractor or engineer be consulted for further evaluation.

North side of the back patio. This crack is of some concern, a similar one is starting on the front concrete porch as well.

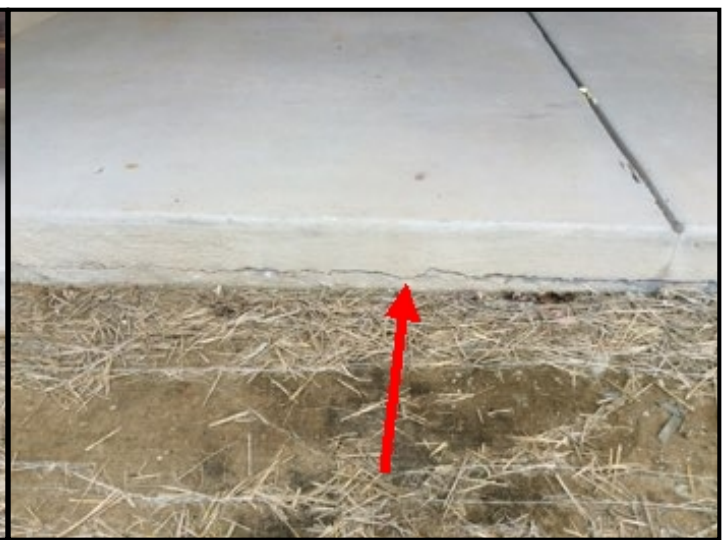
West side of the back concrete patio shows the same crack extending fully around two sides.

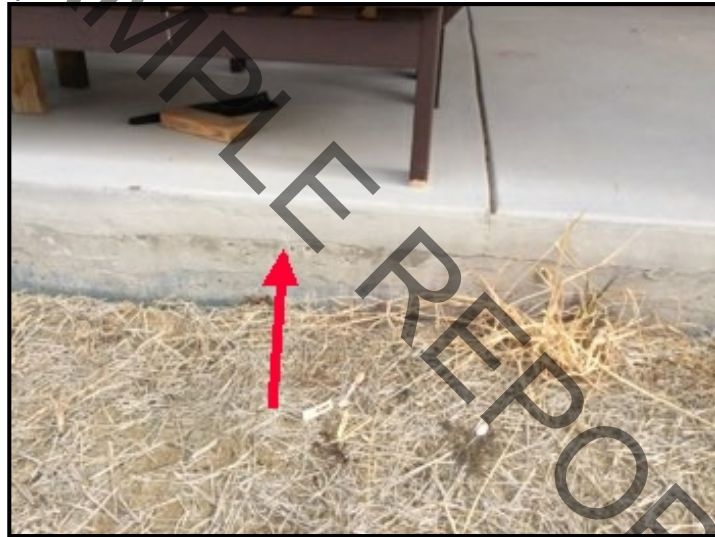
Continuation of the crack on the west side.

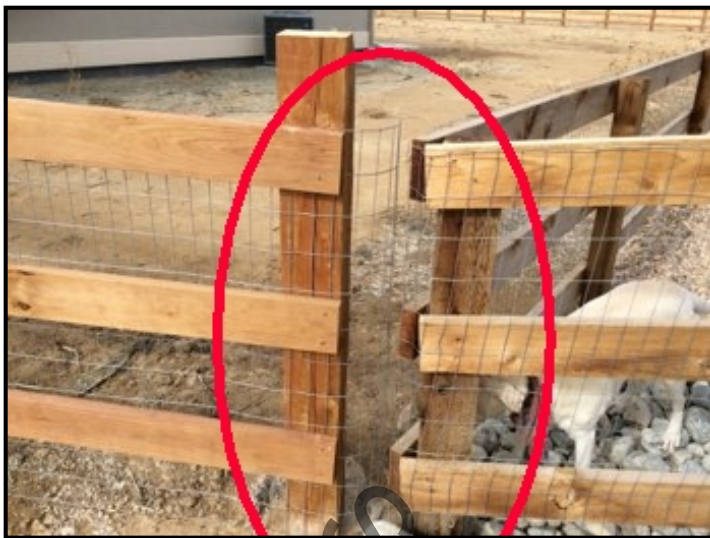
The fence is not properly tied into the neighbors corner.

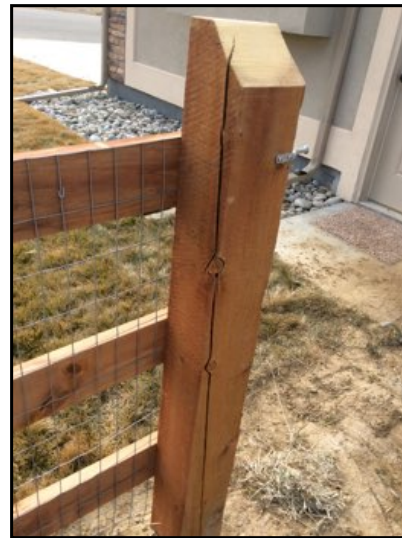
This gate post on the east gate is almost cracked all the way through and should be replaced. It is also cracked on the other side.

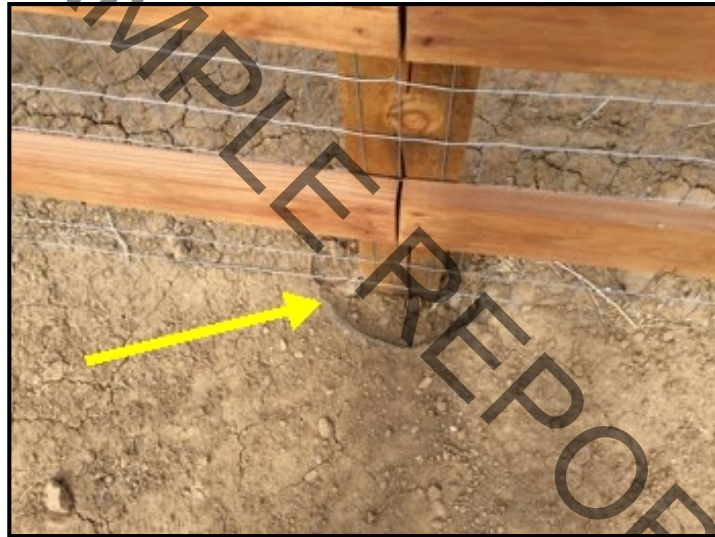
The concrete around the post was not installed very well and creates a bowl to hold water. This will accelerate water damage / rot to the post.

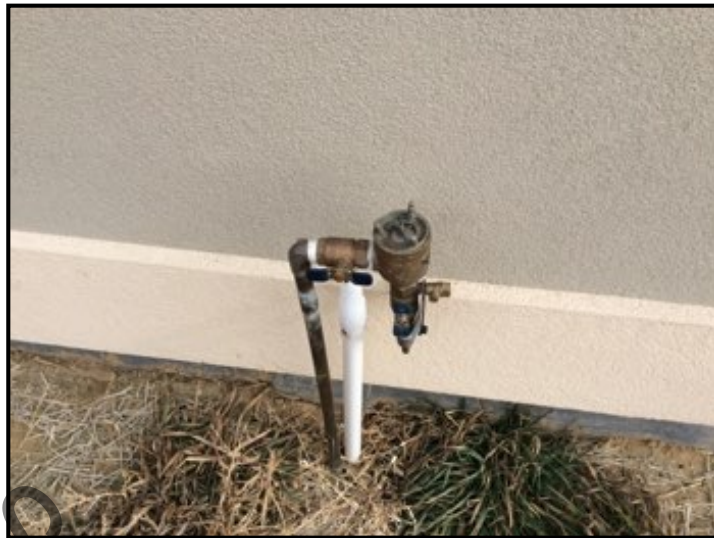
The anti siphon valve has been repaired at least once in the past, and is currently missing the weather protective cap.

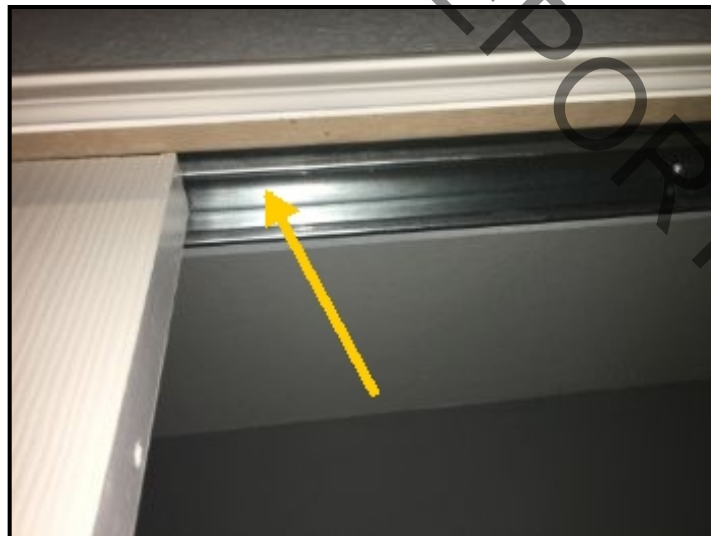
- The closet is in serviceable condition. One of the hallway closet doors has a bent rail and is a little bumpy opening and closing. These are large doors and I would recommend having this rail repaired by a licensed contractor to prevent the door from possibly coming off the rail.

This rail on the hallway closet has a small bend in the track that should be checked.

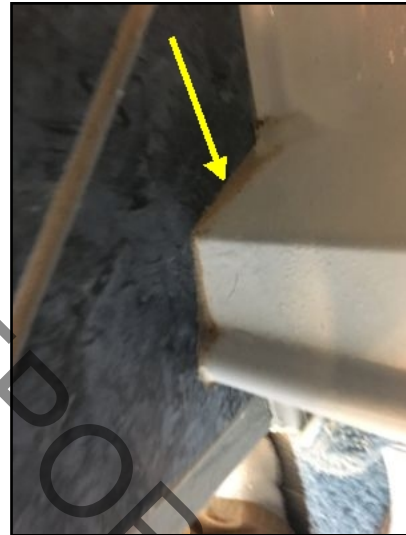
A small pocket of mildew can be seen here on the other side of the door as well.

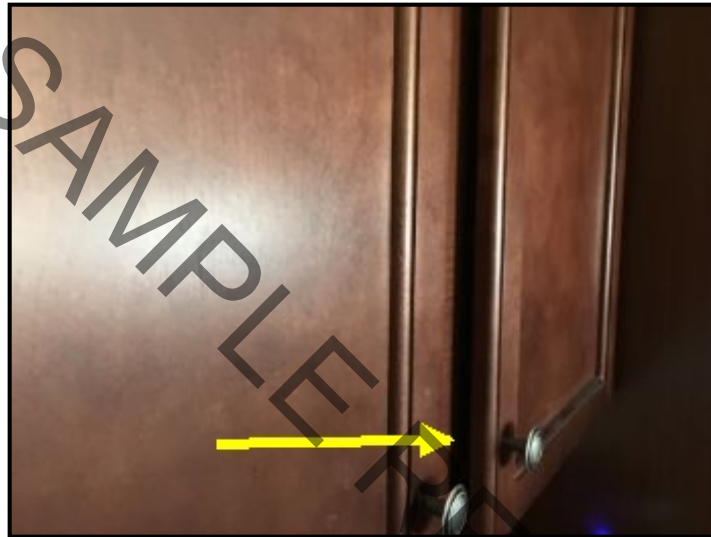
This cabinet did not shut correctly and needs a slight adjustment.

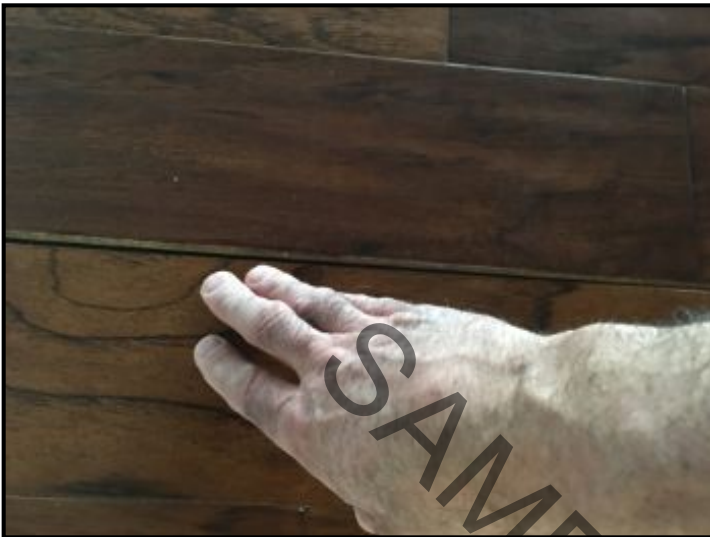
Gap in floor creates flex / bounce on adjacent board.

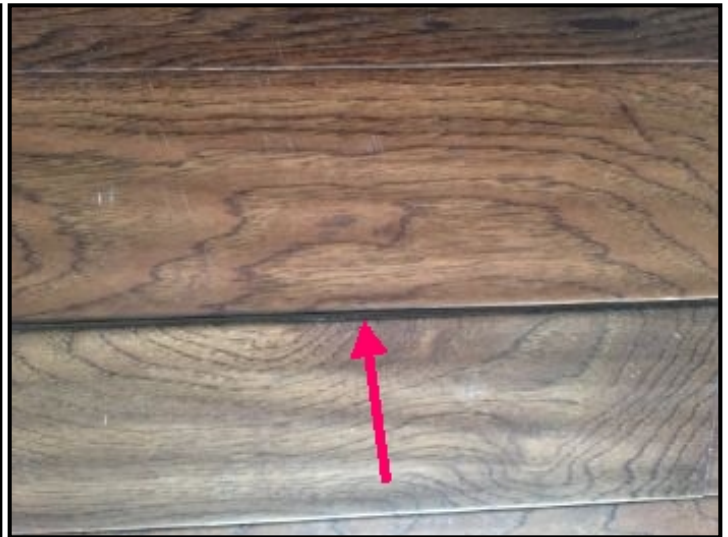
Gap in floor joint.

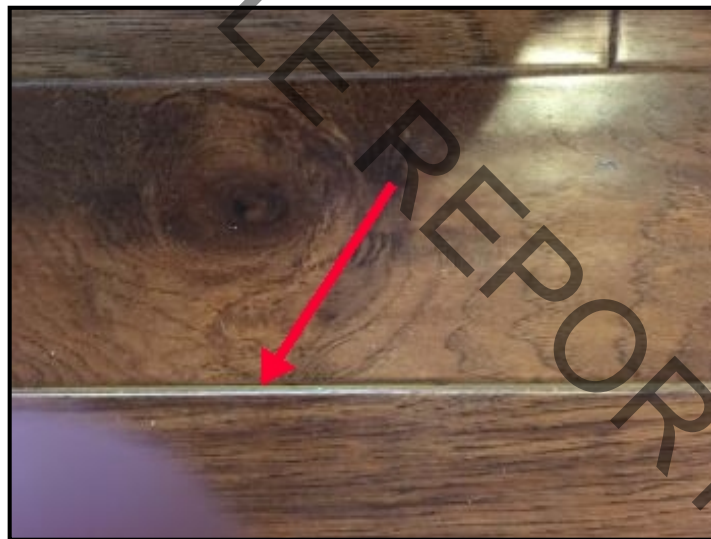
Another gap in the floor board joint.

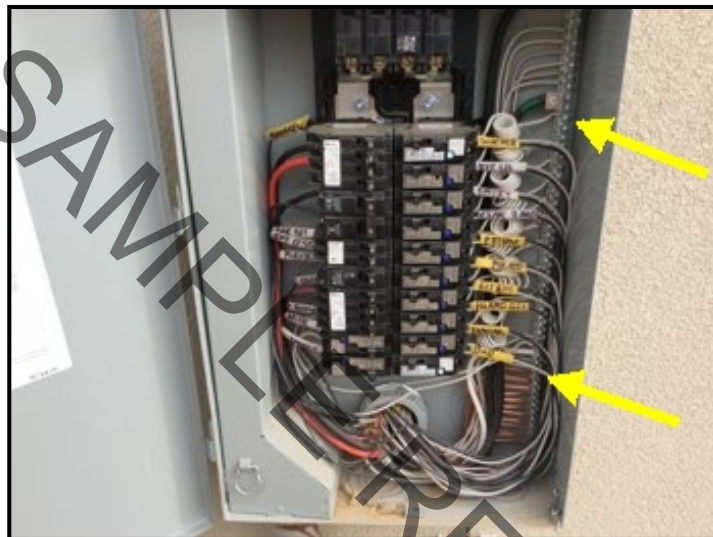
- No major system safety or function concerns noted at time of inspection at main panel box.
- **Grounding / Bonding questionable at panel box. It is standard to separate the grounding and bonding bar, and they appeared to be one long bar during this inspection. I cannot imagine how it passed city inspection without this being the case, however. I would recommend at some point a licensed electrician be consulted for further consultation and evaluation.**

The bonding and grounding bar appear to be connected.

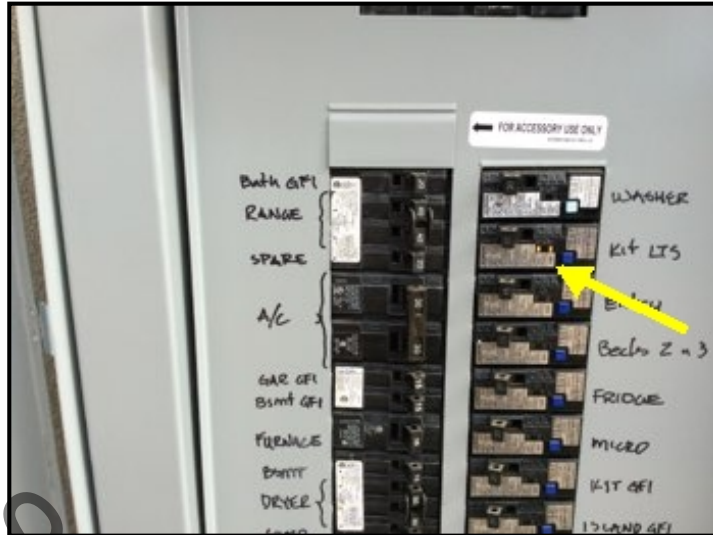
The breaker with the arrow pointing to it has thrown with an arc fault, I cannot reset or test while inspecting as there may be a safety reason it is thrown. I would recommend speaking with the current home owner and asking him to reset it. Should it throw again a licensed electrician should be consulted for further evaluation.

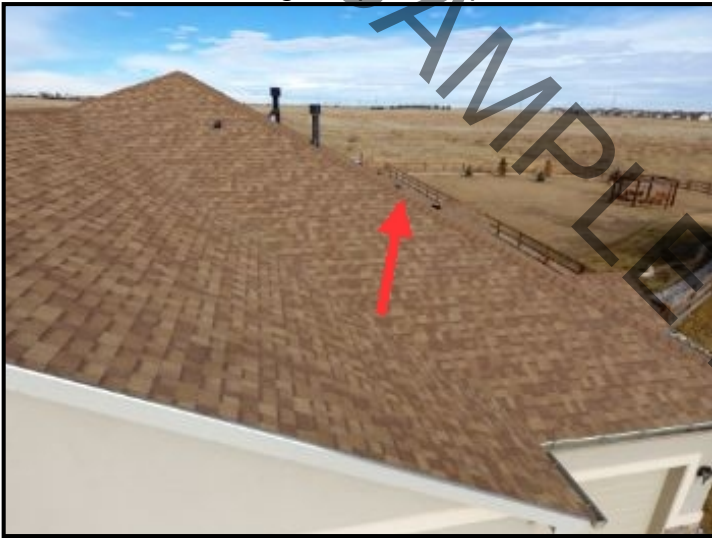
- No major system safety or function concerns noted at time of inspection.
- The hip above the garage is wavy as it rises towards the ridge. It is the inspectors opinion that this is primarily due to poor instalation of the ridge caps and poor framing / blocking beneath. I do not believe this is a safety issue, I would recommend monitoring this area moving forward.

Roof valley and ridge, this ridge is wavy.

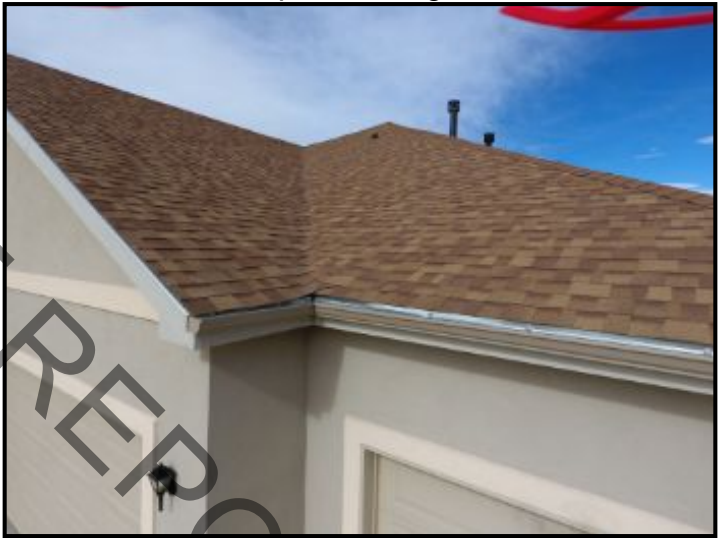
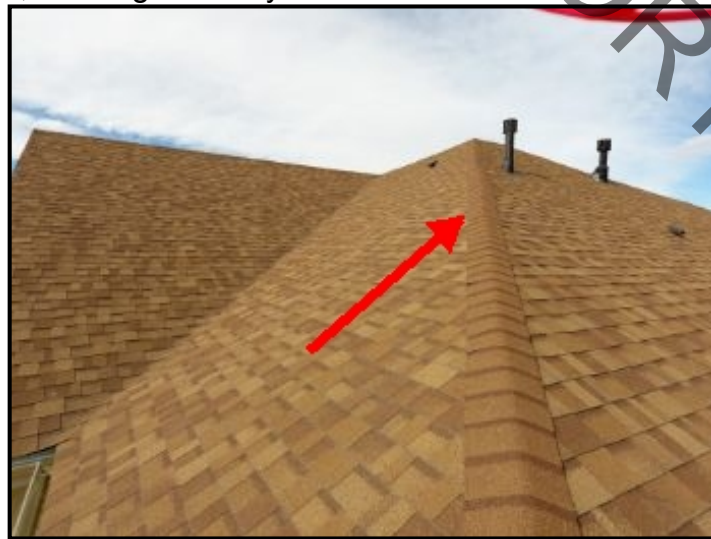
This roof hip is wavy in appearance.

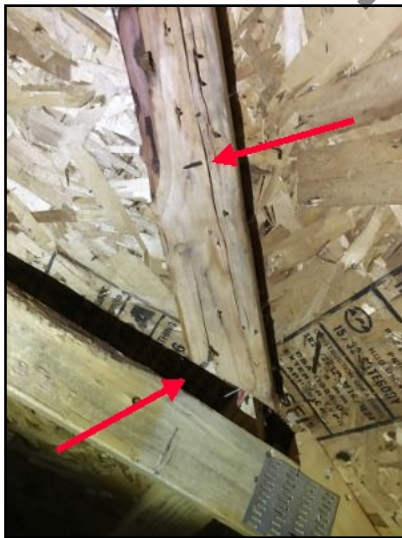
- Due to the framing design of this roof system we recommend limiting the number of roof layers to no more than one layer.
- Being an ex-framer I am not impressed with the craftsmanship concerning the framing and blocking in the attic. It is functioning as intended and I do not see any major issues at the time of this inspection. Only about 40% of the framing and trusses could be inspected as there was 12" of fill insulation that covered up possible routes to move around the attic.
- Could not access all areas of the attic due to limited space.
- Framing is poorly braced.
- Split/Broken framing boards observed.

There is some poor framing and cracked lumber used in the attic for the hip support

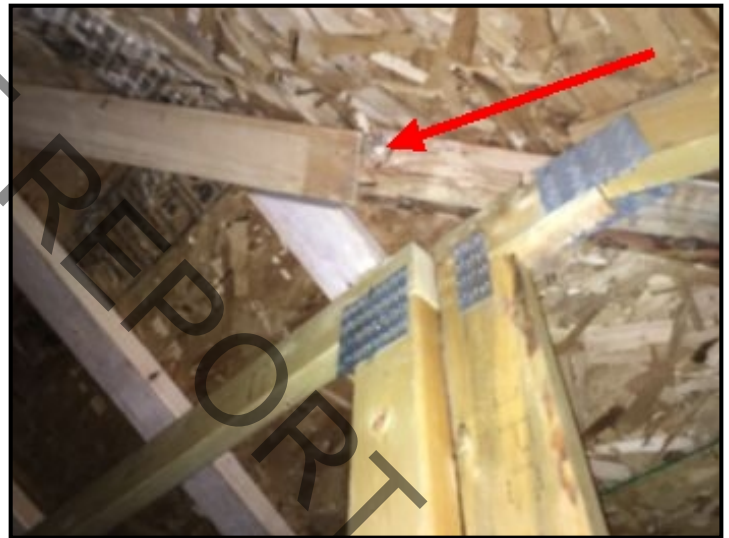
Poor framing practices, although this is not necessarily a structural issue it is just not good professional quality framing.

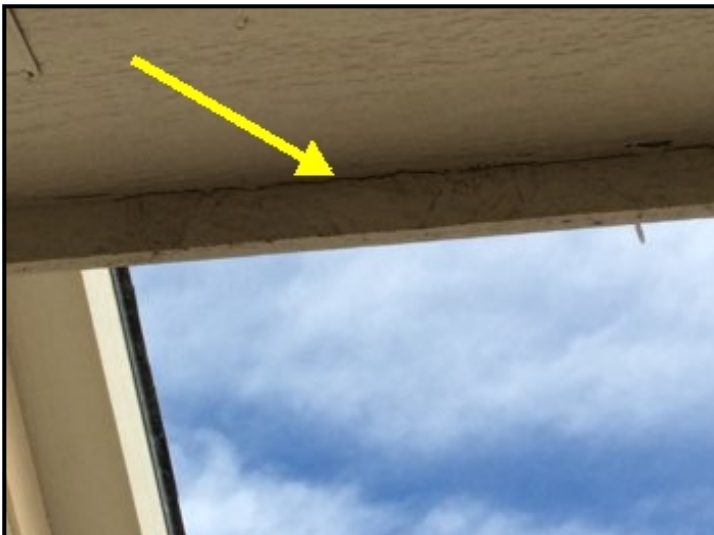
Some paint and caulk routine maintenance is needed here.

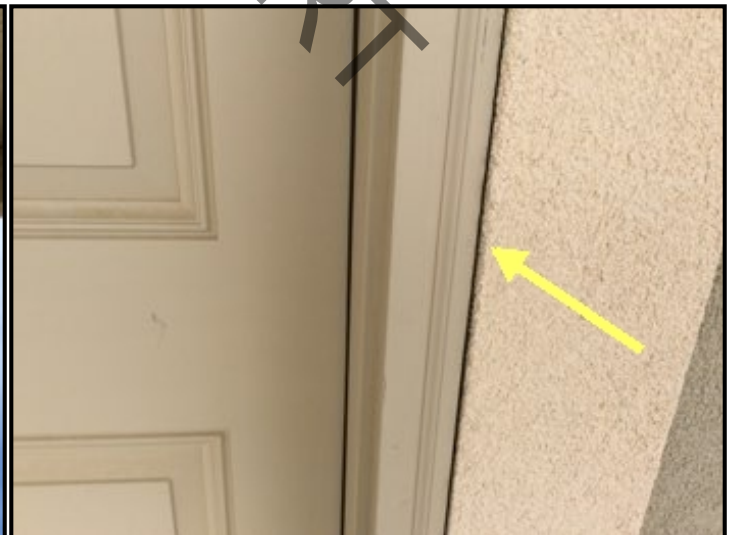
I would recommend these areas between the trim / door jamb in this photo are kept caulked and sealed to prevent excessive moisture intrusion.

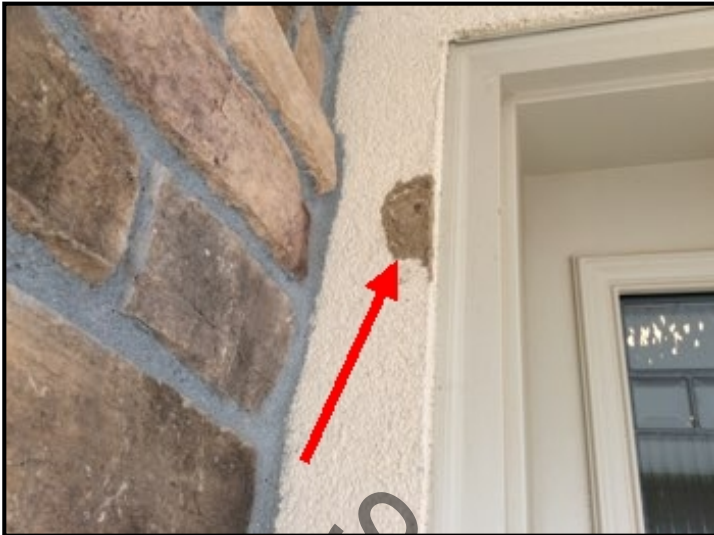
This area of Stucco at the front door appears to have been repaired improperly.

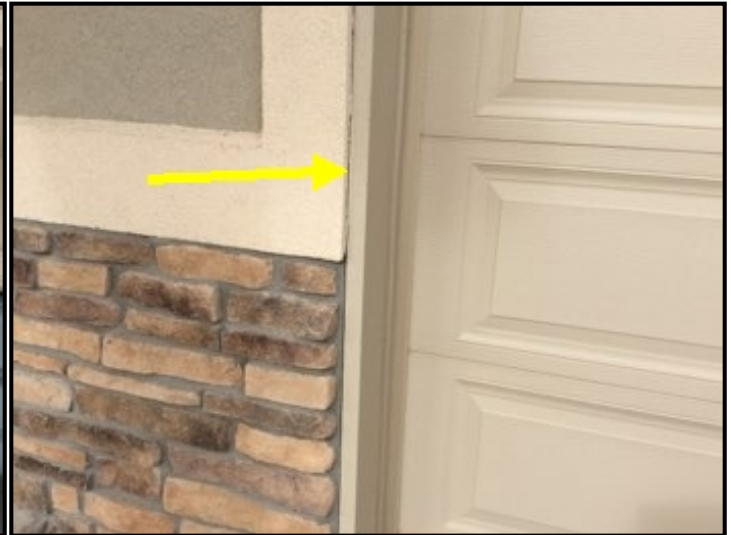
Again the joint between the stucco and trim should be caulked and maintained annually.

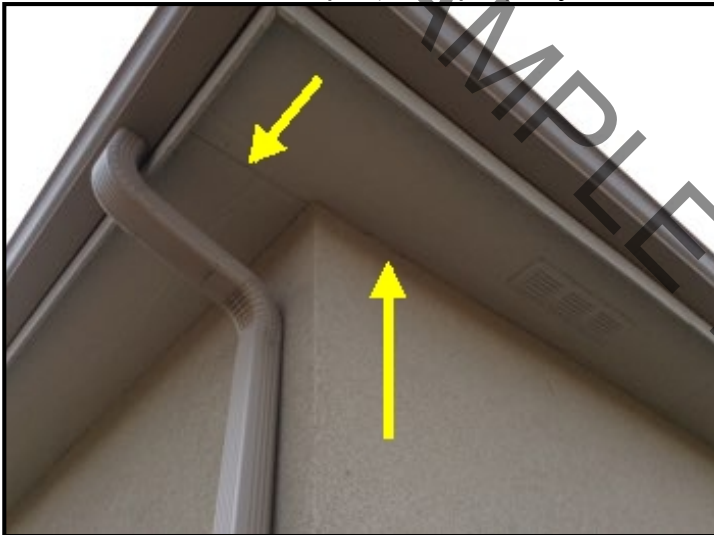
I would recommend keeping these soffit joints sealed / caulked.

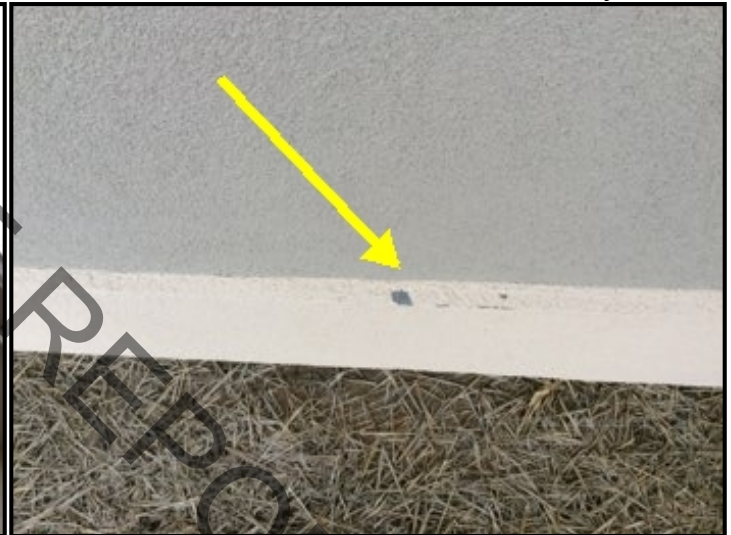
A little touch up paint would be a good idea here.

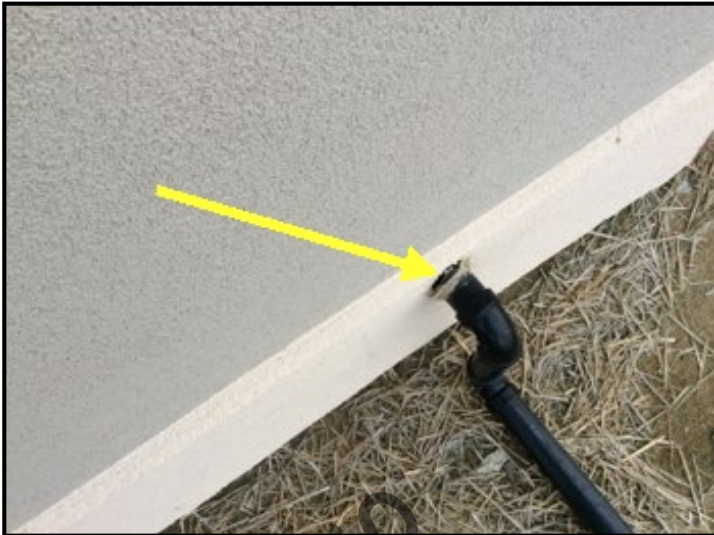
The sump pump drainage pipe needs resealed where it exits the house.

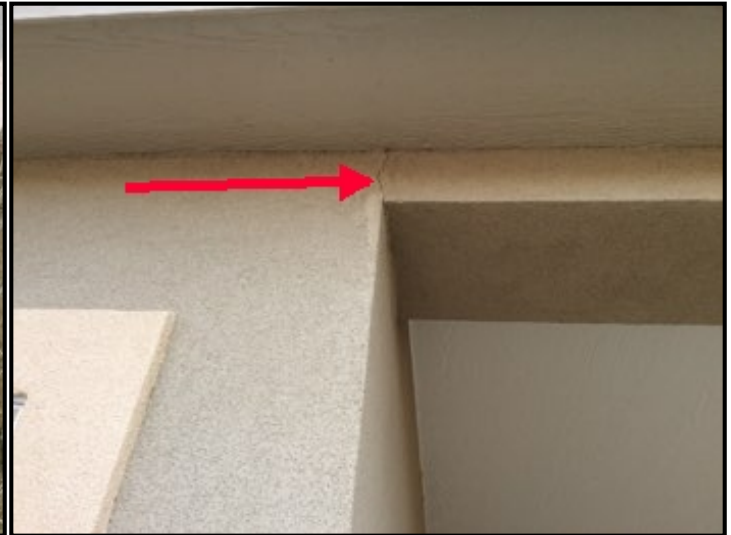
The stucco is slightly cracked here, more than likely this is a shrinkage crack when it was installed. Sealing this crack would be a good idea, internal moisture may worsen it over time.

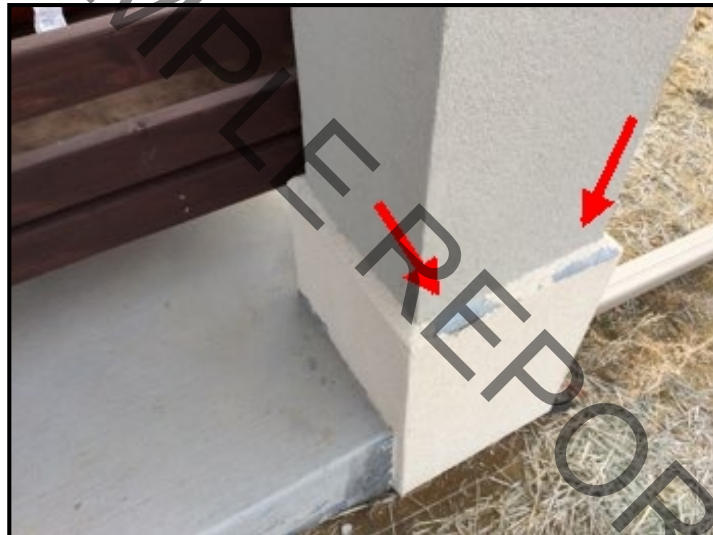
I would recommend touching up the paint in areas like this.

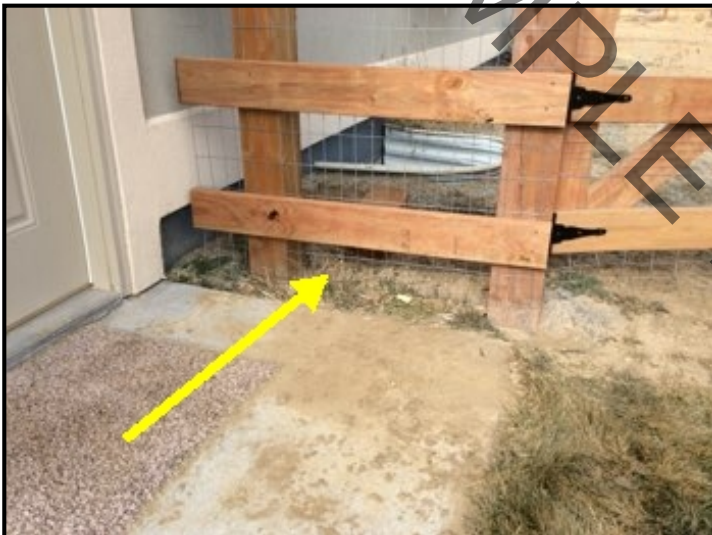
This area by the east gate is draining onto the stoop and will eventually cause problems here. Special attention should be taken when landscaping is complete to promote drainage away from the house but not over the concrete pad.

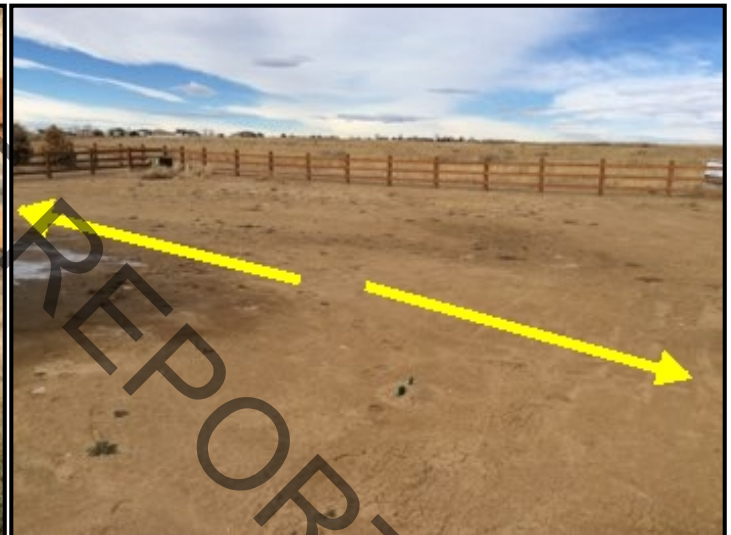
Special attention should be taken while finish grading the back yard, a small swale should be defined to help move water to the planned drainage points.

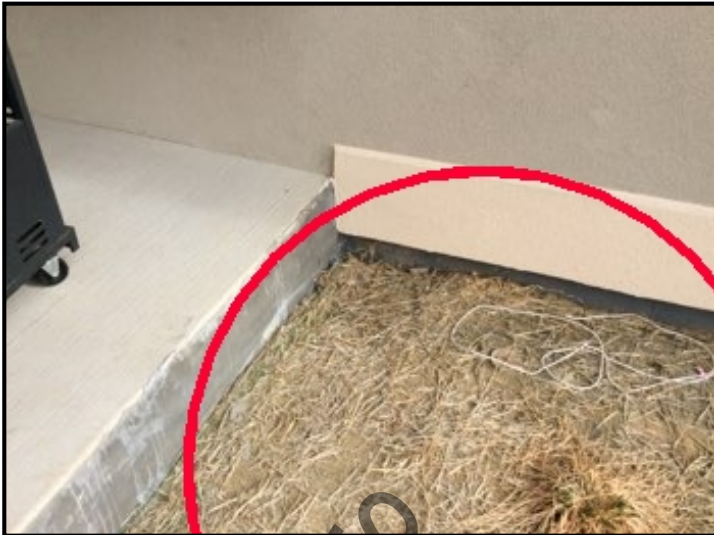
This area is slightly low and may hold water, when the landscaping is completed grading should promote a slope away from the foundation of 6" within the first 10'

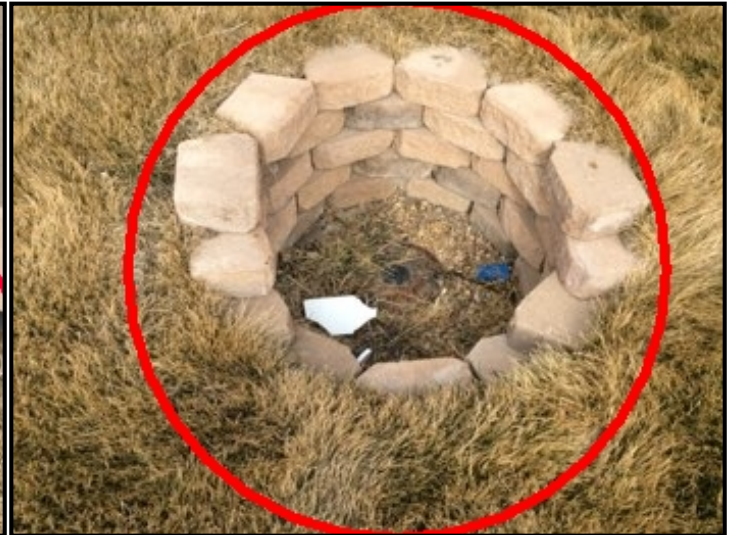
This meter is a safety hazard and should be repaired by a professional contractor as soon as possible. The meter can be raised with a sleeve and dirt filled in around it, there is no reason to have a trip, fall hazard such as this.

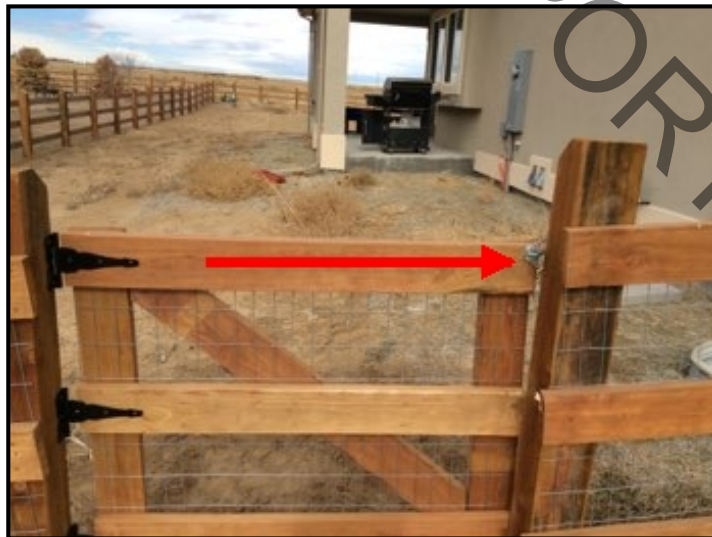
This gate sticks slightly and can be adjusted for easier opening

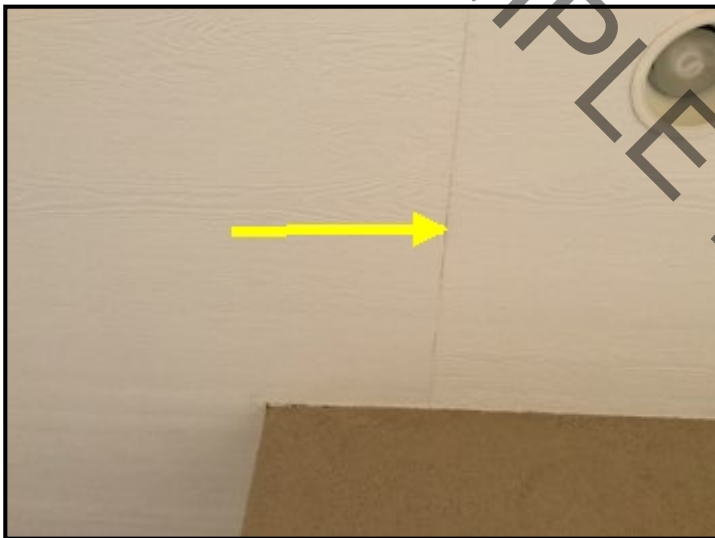
This joint could use a little caulking on the ceiling of the covered patio.

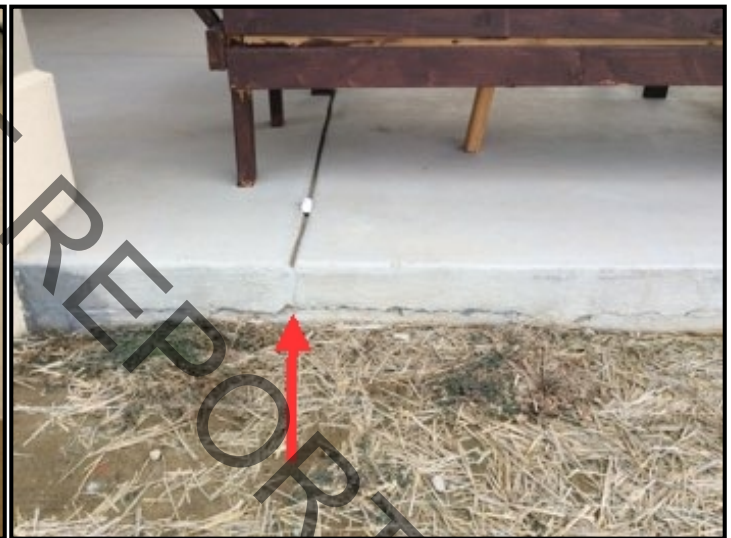
Observations:  
 • The back concrete patio is a 4" slab of concrete and appears to be functioning as intended at the time of this inspection, there is some concern with a crack around two sides of it as noted and pointed out in the pictures.  
 • Common cracks/Seal as needed. There are some small areas that could use caulking to seal up joints and seams.  
 • There is a synonymous crack around 2 sides of the back concrete patio that is of some concern. I would recommend a licensed contractor or engineer be consulted for further evaluation.

North side of the back patio. This crack is of some concern, a similar one is starting on the front concrete porch as well.

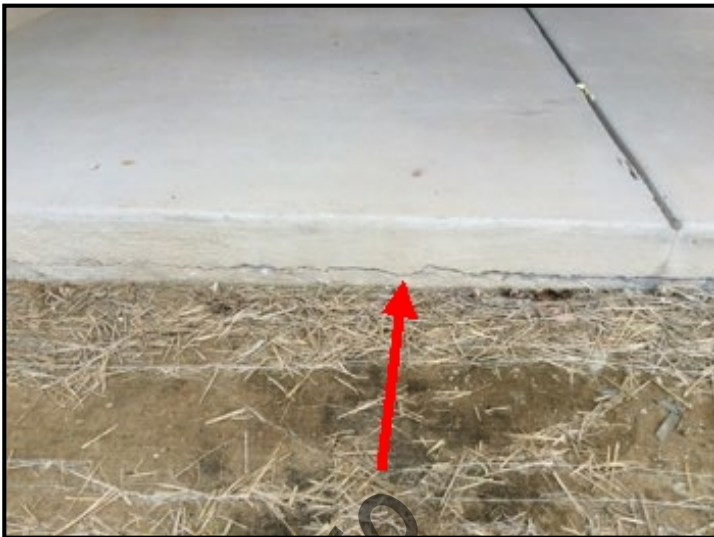
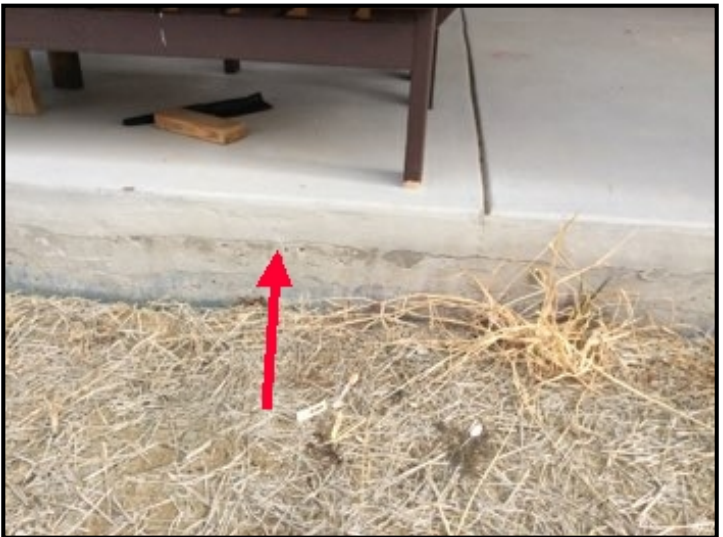
West side of the back concrete patio shows the same crack extending fully around two sides.

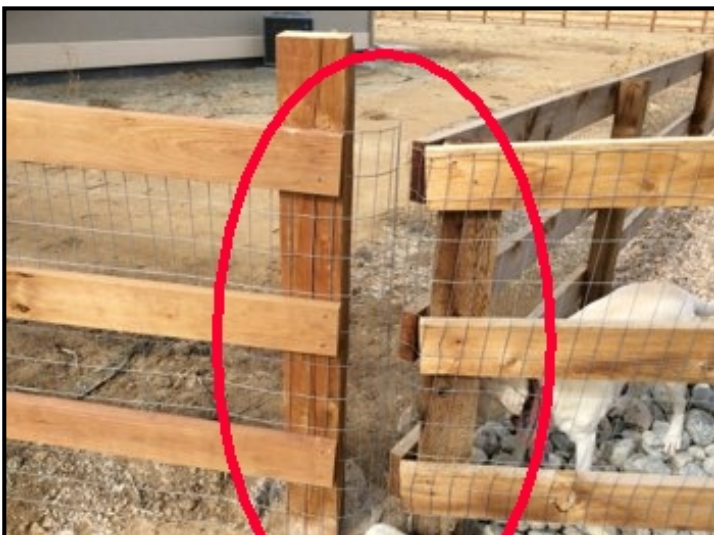
- Wood deterioration observed. Suggest repairs/replacement as needed.
- There are a few concerns to note with the fence. It is not completed correctly on the east side where it butts into the neighbor's fence. The gate post on the east gate is almost cracked all the way through. The concrete around several of the post has been poorly done. Best practice would be to bring the concrete to grade level and bevel it away from the post to keep water from sitting at the base, water held around the base of the post will accelerate rotting and deterioration of the post. There is almost a natural bowl to hold water around several of the post.

The fence is not properly tied into the neighbors corner.

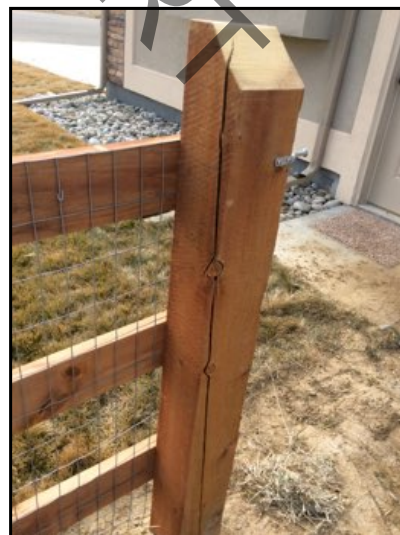
This gate post on the east gate is almost cracked all the way through and should be replaced. It is also cracked on the other side.

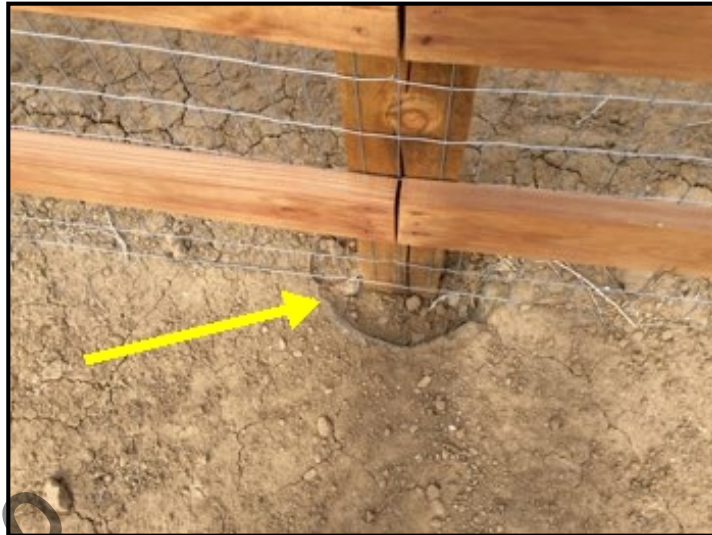
The concrete around the post was not installed very well and creates a bowl to hold water. This will accelerate water damage / rot to the post.

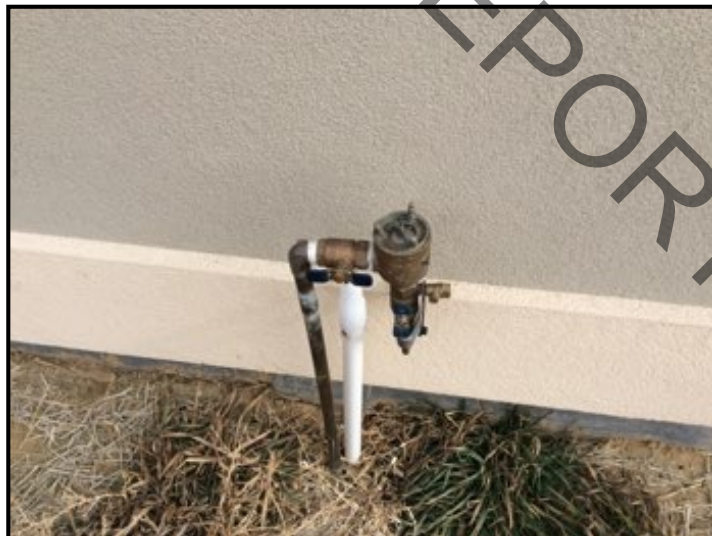
The anti siphon valve has been repaired at least once in the past, and is currently missing the weather protective cap.
