## **Sherlock Homes Inspection & Appraisal, LLC**

1234 ABC Lane  
Denver CO 80202

# Summary

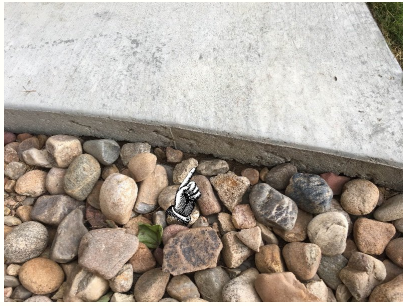
The grade is eroding on this side of the sidewalk that leads to the back yard. It should be built up to prevent further erosion and problems.

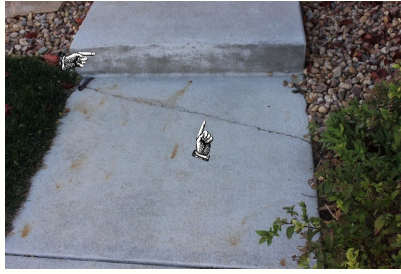
The sidewalk to the front door has a crack in it that indicates some settling, efflorescence can also be seen on the concrete in this area which leads me to believe it is holding water. The grade may need to be adjusted to allow proper drainage or the walk may need repaired and raised.

The sidewalk to the front door has a settling crack and efflorescence stains that may indicate drainage problems..

A licensed contractor should be contacted for these repairs for further evaluation.

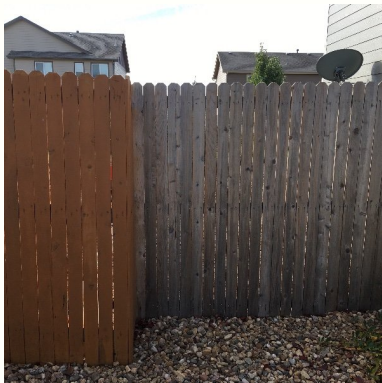
The fence was inspected with no major issues or concerns noted. The fence is almost 4 years old and is deteriorating from the elements, a regular coat of sealant or stain every 3-5 years would help to extend the life of the fence greatly.

The neighbors fence can be seen on the left with a good coat of stain on it. This will help the fence last much longer.

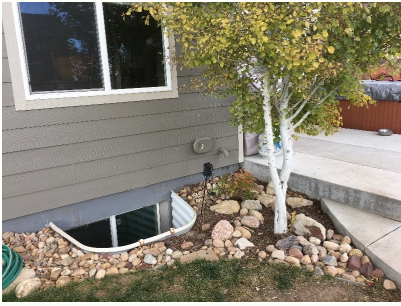
There is one Aspen tree, a rose bush by the back garage door, and the front bedding area between the front entry sidewalk and the house that all have plantings too close to the foundation. These plantings are not only getting additional irrigation to them that is harmful for the foundation, the roots from larger shrubs, and any tree typically hold moisture that can be detrimental to the foundation life as well. the smaller shrubs should be kept cut low, the drip irrigation moved away from the foundation as far as possible, and the Aspen tree and rose bush should be either transplanted elsewhere or removed. A licensed contractor should be consulted for further evaluation and repair.

This tree is too close to the foundation and should be moved a minimum of 6' from the foundation. The smaller peonies in the back of the tree is probably ok.

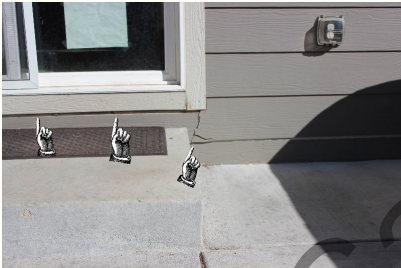
The patio slab the builder poured when the house was built was poured right over the siding on the home. As this patio settled it pulled the siding down off the house. The homeowner has since correctly fixed the siding by removing the old siding that was trapped between the house and concrete slab, installing proper flashing, and reinstalling the new siding. The paint on the house does not match because the old paint has faded and the new paint is fresh and bright. The new paint will eventually fade and match, or a paint supplier may be able to match the faded paint to match the old paint on the house. Pictures of this repair are below.

Here you can see the gap under the door, and the cracking that was created as the concrete settled and pulled the siding off the house.

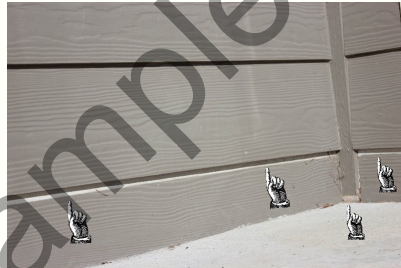
Again you can see where the concrete slab is pulling the siding down as it settles. The 1"x1" trim piece in the corner stayed in place, but it was found to have water penetration during the repair do to the lack of proper Z flashing under the siding / trim and over the concrete.

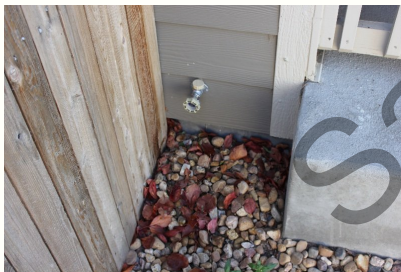
Grading at the house wall was inspected and there were no concerns or issues noted. The hose spigots do not have splash blocks under them, addition of the splash blocks will help to promote excess water from the spigot to move away from the foundation.

Splash blocks should be added beneath the hose spigot to promote excessive water out of the spigot to move away from the foundation.

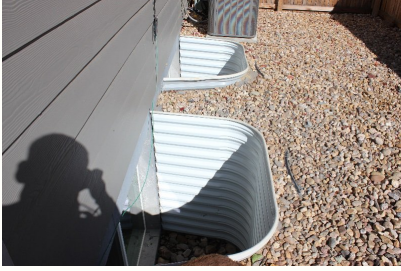
The window wells were inspected and there were no issues or concerns at the time of this inspection. The window wells do not have protective covers over them to prevent an accidental fall into the well. This may be a good upgrade to add in the future for safety reasons. These covers will need to be able to be removed

These window wells could have protective covers over them to prevent an accidental fall into the well.

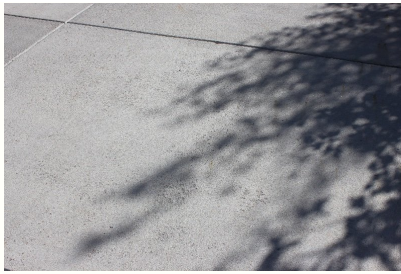
Although this driveway is only a 4 years old it is spalling and has a few cracks that should be monitored going forward. The spalling was most likely do to excess moisture in the concrete when it was poured. One of the cracks in the driveway was beginning to lift. The driveway is functioning as intended currently with no major issues. If the cracks continue to separate or lift a licensed contractor should be consulted for further evaluation and repair.

The spalling seen here will continue to worsen with the freeze thaw cycle of the local climate.

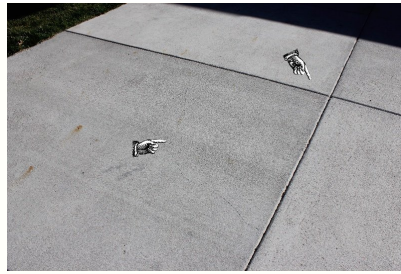
The corner of the slab with the crack in it is starting to lift.

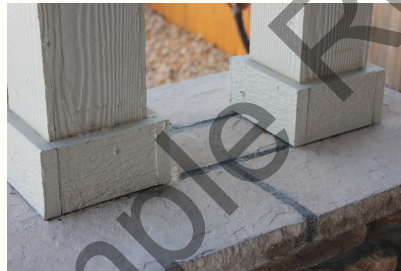
The front porch was inspected with no major issues or concerns noted. There was a settling crack on the top of the porch that should be monitored going forward. The wood columns that rest on the natural stone cap should be capped at the bottom of the wood column and the top of the stone cap intersection to prevent water penetration.

The base of these columns should be caulked to prevent water penetration.

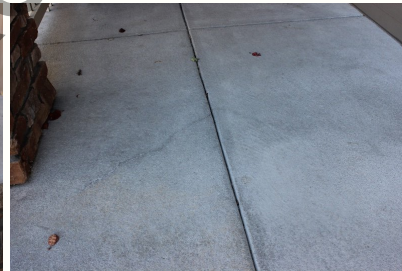
This V crack running through an expansion joint should be monitored moving forward.

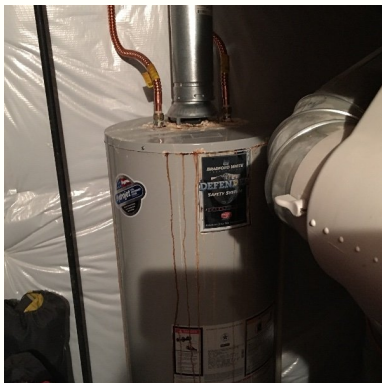
The hot water tank was inspected and has obviously had a past leak. Upon further examination the tank was beginning to rust fairly significantly. This will certainly shorten the life of this unit. The hot water tank should be monitored ongoing and replaced as necessary by a licensed contractor.

Hot water tank showing signs of past leak and rust.. Heavy mineral buildup / efflorescence can be observed on the top and in the pan below.

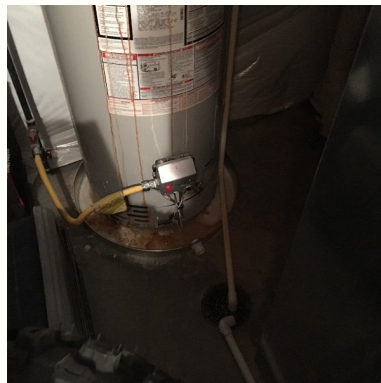
Water tank pan showing signs of past leaks.

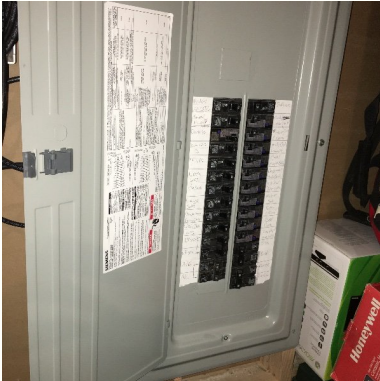
The space in front of the panel should be cleared for access.

Sub panel with all circuits labeled.

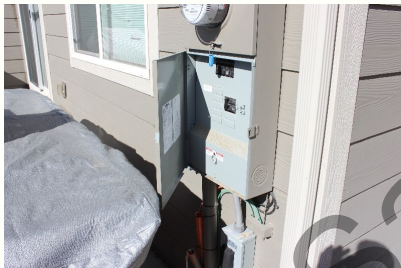
There is not proper clearance in front of the main panel as the hot tub blocks access and doesn't allow the door to open freely unless the cover of the hot tub is removed. It was a little intimidating inspecting the main panel with a tub full of water open right next to it. The hot tub should be relocated further from the panel for access and safety.

This main panel door does not properly open without removing the hot tub cover.

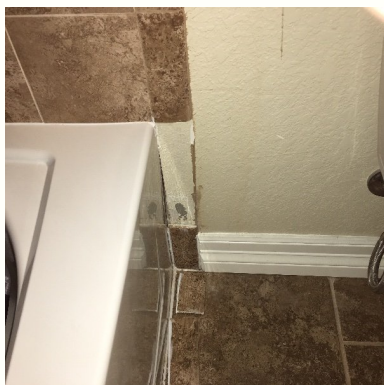
Tile has fallen off the outside of the bathtub and the caulk seal has been compromised. This should be repaired asap to avoid excessive moisture to the structural components around the tub. As well the caulking around the tub needs maintenance. A licensed contractor should be consulted for further evaluation and repair.

Tile has fallen off the wall either due to improper installation or settling. This should be repaired and recalled as soon as possible.

Moisture reading were taken with a moisture meter around the tub and the readings were high where the tile has displaced off the wall.
