Sherlock Homes Inspection & Appraisal, LLC

1234 ABC Lane
Denver CO 80202

Summary

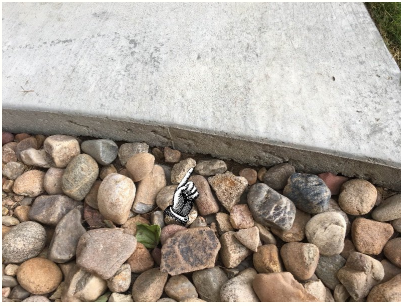
The grade is eroding on this side of the sidewalk that leads to the back yard. It should be built up to prevent further erosion and problems.

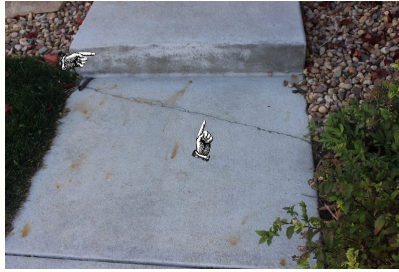
The sidewalk to the front door has a crack in it that indicates some settling, efflorescence can also be seen on the concrete in this area which leads me to believe it is holding water. The grade may need to be adjusted to allow proper drainage or the walk may need repaired and raised.

The sidewalk to the front door has a settling crack and efflorescence stains that may indicate drainage problems..

A licensed contractor should be contacted for these repairs for further evaluation.

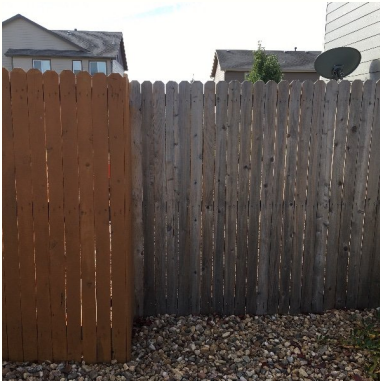
The fence was inspected with no major issues or concerns noted. The fence is almost 4 years old and is deteriorating from the elements, a regular coat of sealant or stain every 3-5 years would help to extend the life of the fence greatly.

The neighbors fence can be seen on the left with a good coat of stain on it. This will help the fence last much longer.

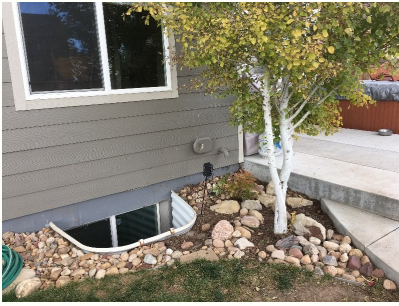
There is one Aspen tree, a rose bush by the back garage door, and the front bedding area between the front entry sidewalk and the house that all have plantings too close to the foundation. These plantings are not only getting additional irrigation to them that is harmful for the foundation, the roots from larger shrubs, and any tree typically hold moisture that can be detrimental to the foundation life as well. the smaller shrubs should be kept cut low, the drip irrigation moved away from the foundation as far as possible, and the Aspen tree and rose bush should be either transplanted elsewhere or removed. A licensed contractor should be consulted for further evaluation and repair.

This tree is too close to the foundation and should be moved a minimum of 6' from the foundation. The smaller peonies in the back of the tree is probably ok.

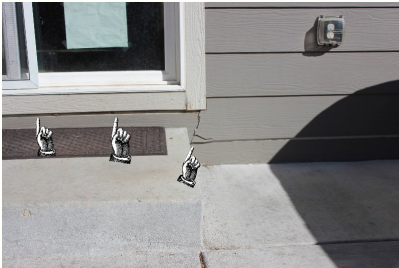
The patio slab the builder poured when the house was built was poured right over the siding on the home. As this patio settled it pulled the siding down off the house. The homeowner has since correctly fixed the siding by removing the old siding that was trapped between the house and concrete slab, installing proper flashing, and reinstalling the new siding. The paint on the house does not match because the old paint has faded and the new paint is fresh and bright. The new paint will eventually fade and match, or a paint supplier may be able to match the faded paint to match the old paint on the house. Pictures of this repair are below.

Here you can see the gap under the door, and the cracking that was created as the concrete settled and pulled the siding off the house.

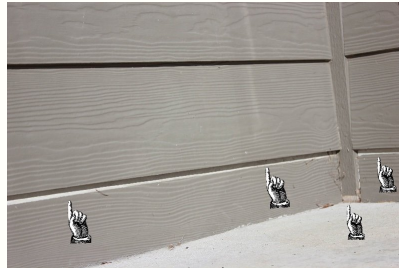
Again you can see where the concrete slab is pulling the siding down as it settles. The 1"x1" trim piece in the corner stayed in place, but it was found to have water penetration during the repair do to the lack of proper Z flashing under the siding / trim and over the concrete.

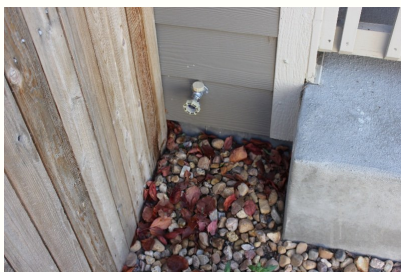
Grading at the house wall was inspected and there were no concerns or issues noted. The hose spigots do not have splash blocks under them, addition of the splash blocks will help to promote excess water from the spigot to move away from the foundation.

Splash blocks should be added beneath the hose spigot to promote excessive water out of the spigot to move away from the foundation.

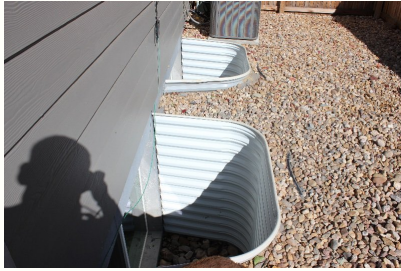
The window wells were inspected and there were no issues or concerns at the time of this inspection. The window wells do not have protective covers over them to prevent an accidental fall into the well. This may be a good upgrade to add in the future for safety reasons. These covers will need to be able to be removed

These window wells could have protective covers over them to prevent an accidental fall into the well.

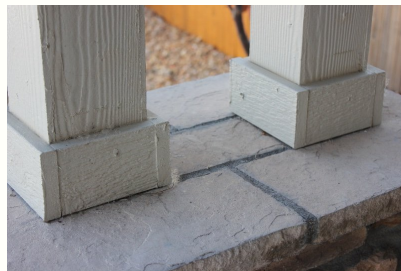
The base of these columns should be caulked to prevent water penetration.

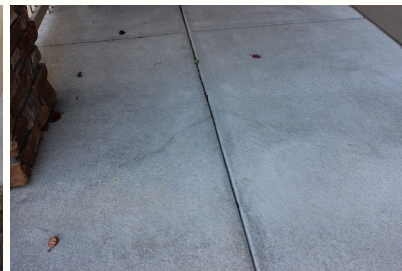
The front porch was inspected with no major issues or concerns noted. There was a settling crack on the top of the porch that should be monitored going forward. The wood columns that rest on the natural stone cap should be capped at the bottom of the wood column and the top of the stone cap intersection to prevent water penetration.

This V crack running through an expansion joint should be monitored moving forward.

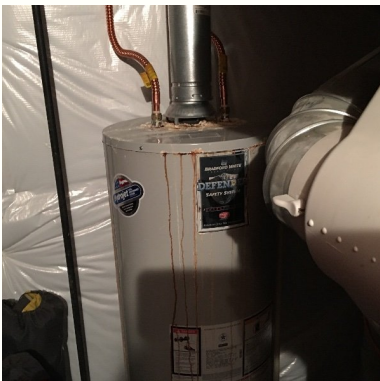
The hot water tank was inspected and has obviously had a past leak. Upon further examination the tank was beginning to rust fairly significantly. This will certainly shorten the life of this unit. The hot water tank should be monitored ongoing and replaced as necessary by a licensed contractor.

Hot water tank showing signs of past leak and rust.. Heavy mineral buildup / efflorescence can be observed on the top and in the pan below.

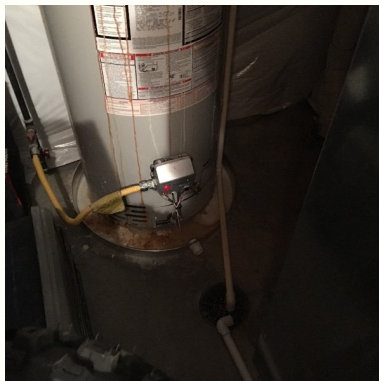
Water tank pan showing signs of past leaks.

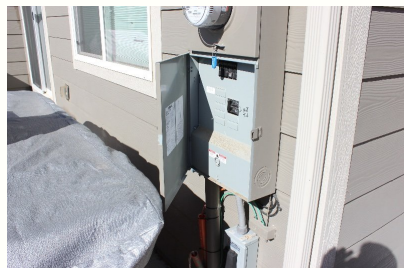
There is not proper clearance in front of the main panel as the hot tub blocks access and doesn't not allow the door to open freely unless the cover of the hot tub is removed. It was a little intimidating inspecting the main panel with a tub full of water open right next to it. The hot tub should be relocated further from the panel for access and safety.

This main panel door does not properly open without removing the hot tub cover.

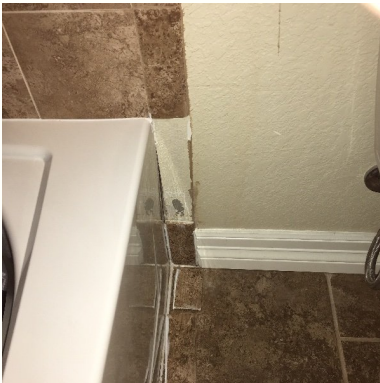
Tile has fallen off the outside of the bathtub and the caulk seal has been compromised. This should be repaired asap to avoid excessive moisture to the structural components around the tub. As well the caulking around the tub needs maintenance. A licensed contractor should be consulted for further evaluation and repair.

Tile has fallen off the wall either due to improper installation or settling. This should be repaired and recalled as soon as possible.

Moisture reading were taken with a moisture meter around the tub and the readings were high where the tile has displaced off the wall.
