Sherlock Homes Inspection & Appraisal, LLC

John & Jane Smith
1234 ABC Lane
Denver, CO 80202
Phone: 303.555.5555

1234 ABC Lane
Denver CO 80202

Inspection Information

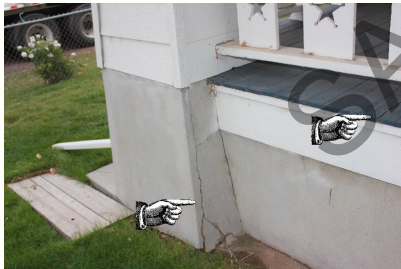
Cracking in front porch column. Wood deterioration on front porch decking.

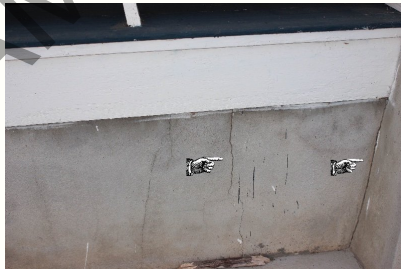
Cracks in front supporting wall, and separation crack in column.

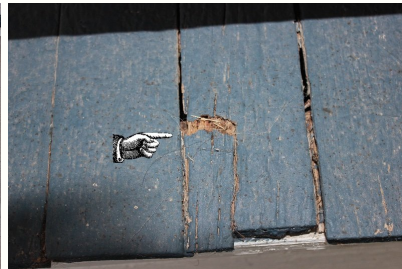
Wood deterioration on front porch.

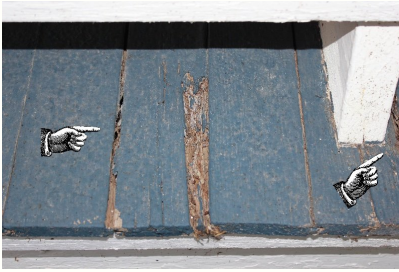
Wood deterioration on front porch decking.

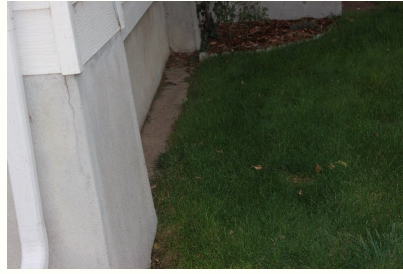
Negative grade at front porch supporting wall.

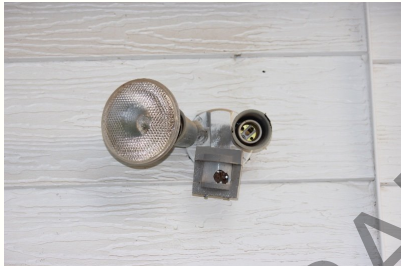
This light is missing a bulb and it appears the motion sensor may be broken. A licensed contractor should be consulted for repair or replacement.

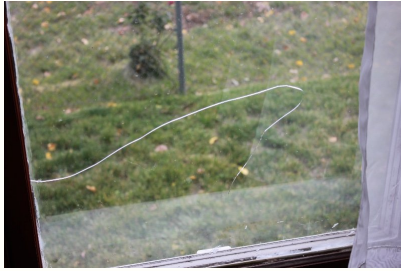
Cracked window

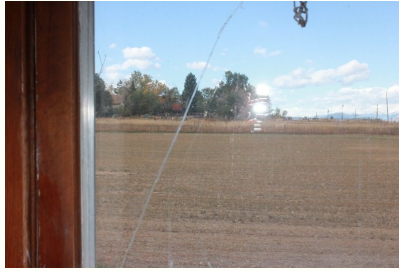
Cracked window.

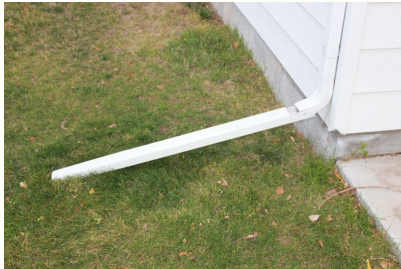
Downspout extension should be extended out further to a minimum of 6' or more from the foundation.

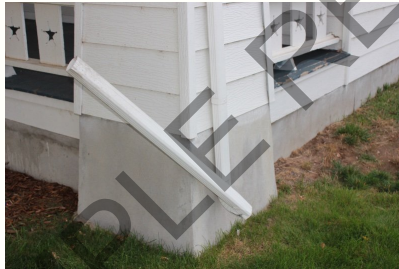
Downspout extension should be kept down to help move roof water away from the foundation

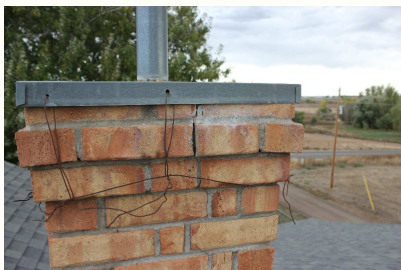
Rain cap improperly secured to chimney. Mortar failure and cracking in the brick joints.

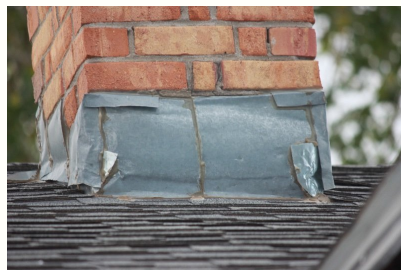
Improperly installed flashing at base of chimney on roof.

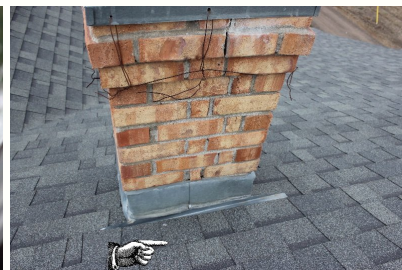
This side of the chimney should have cricket flashing installed to divert the water around the structure.

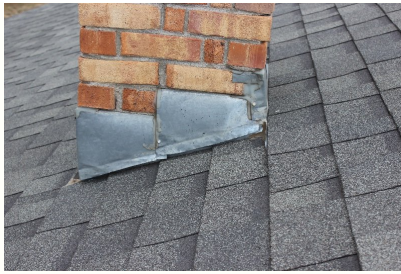
Improperly installed step flashing.

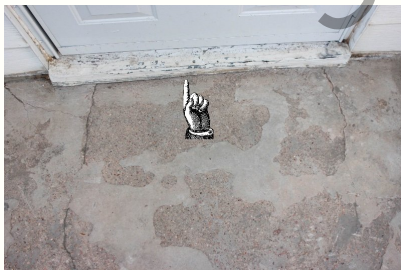
Wood deterioration on back door leading to the main floor.

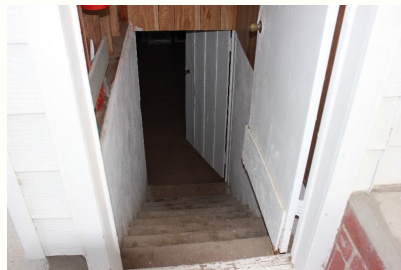
Basement access door from the backyard improperly opens over the stairs. This is a safety hazard and the door needs to be reversed to swing outwards. The door is not designed for exterior use and thus is deteriorating and should be replaced at the same time.

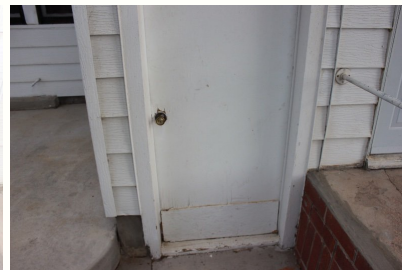
Exterior door leading to the basement from the backyard. Showing signs of water damage and deterioration.

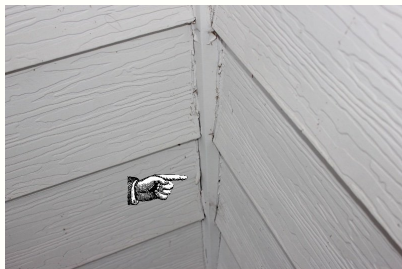
Some minor caulking maintenance is needed around the joints of the siding and trim by a licensed contractor.

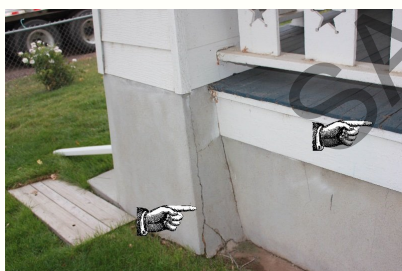
Cracking in column may be superficial or structural, there is no way to tell from a visual inspection.

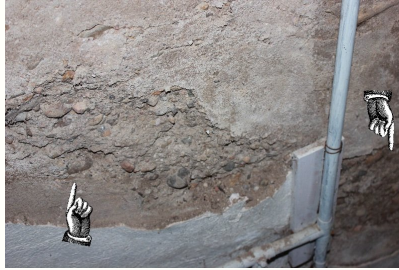
Vertical crack continues into the main room of the basement.

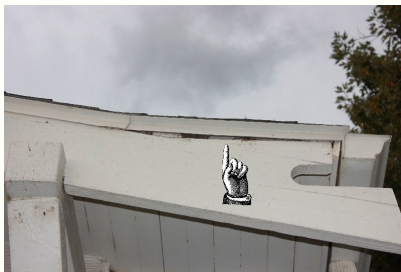
Flashing should properly extend over this gap and sufficiently onto the 2"x8" outer roof rafter below it.

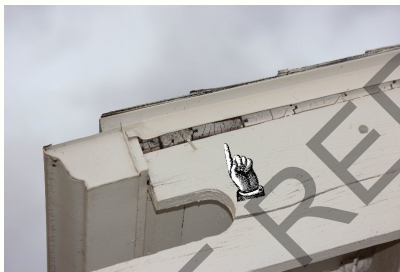
Improperly installed flashing, the flashing length is not sufficient to cover the gap, thus allowing water penetration.

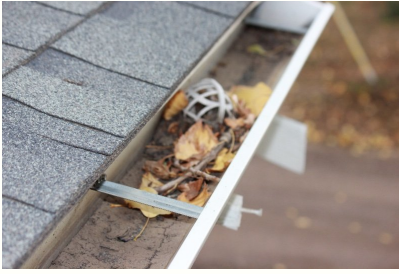
Debris and sediment build up in the gutters on the roof.

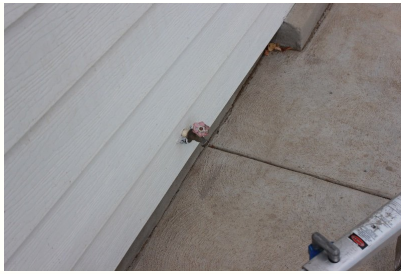
Outdated hose bib, a splash pan should be installed underneath this bib to help move water away from the foundation while it is in use.

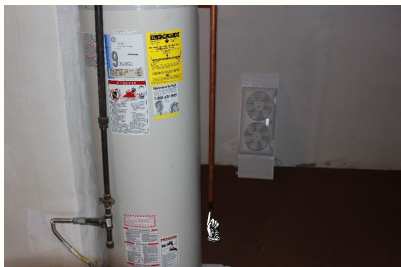
Improper termination of TPR relief valve drain pipe.

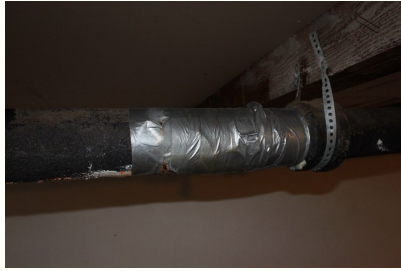
This pipe appears to have an improper repair to it, and is not properly supported.

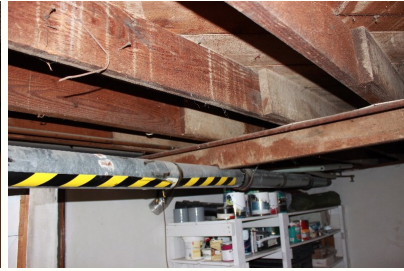
These sections of the drain waste pipe appear to have been improperly repaired with sheet metal duct pipes and sealant.

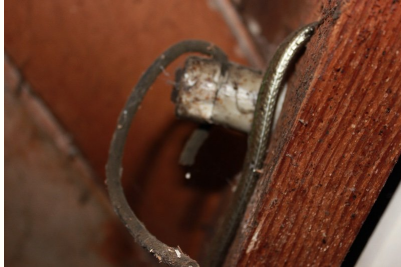
What appears to be abandoned Knob & Tube wiring in the basement rafters.

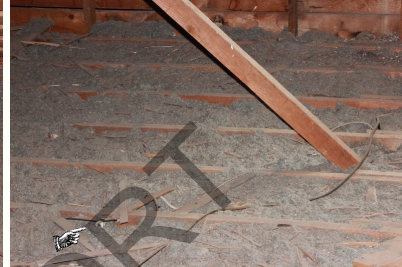
More knob and tube wiring improperly installed in the attic.

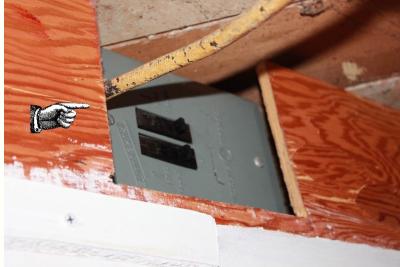
This sub-panel located in the basement rafters is not in a proper location.

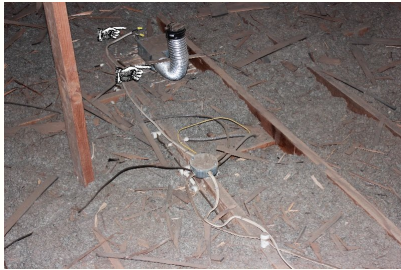
Improper termination of bathroom fan, wiring splice is not properly contained in an approved covered box.

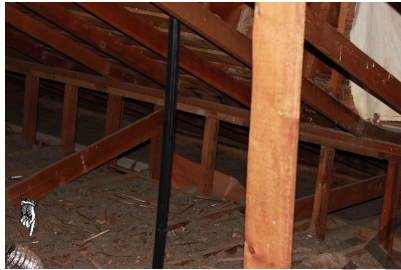
Improper termination of bathroom vent in attic.

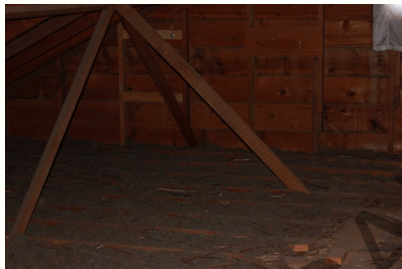
These roof supports should to be checked and verified by a structural engineer as properly installed.

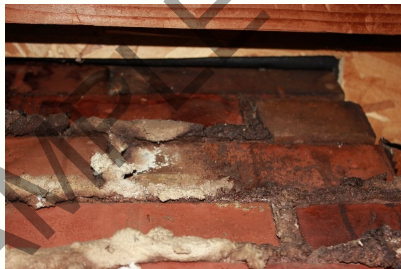
mortar joints on chimney stack in the attic showing deterioration. efflorescence is also present indicating past water damage.

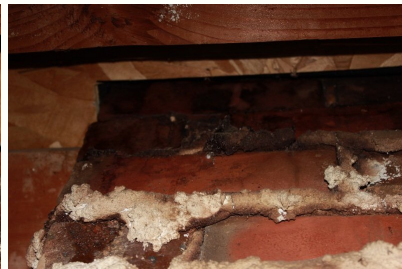
Brick chimney stack in attic showing improper repair to deteriorating mortar joints.

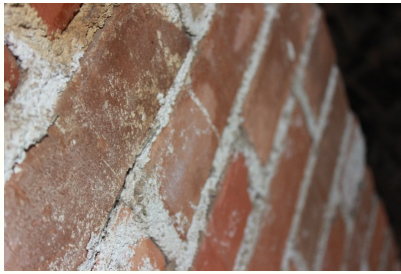
Chimney stack with deteriorating and improperly repaired mortar joints.

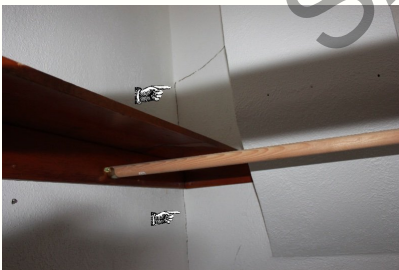
It is possible that the chimney stack encased in this wall is failing and causing this crack.

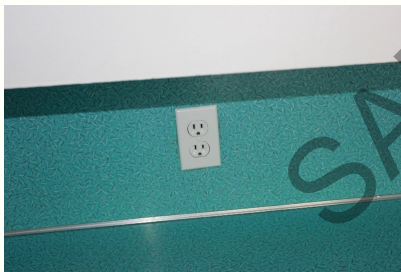
Non GFCI outlet in the kitchen.

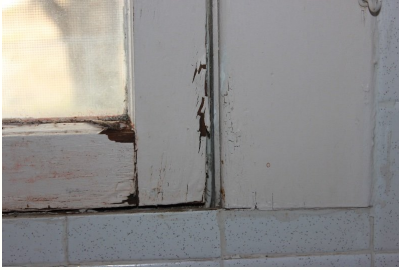
Water damage to the window sash and frame.

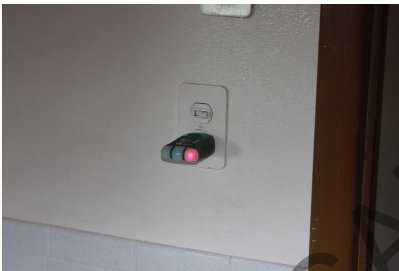
Electrical outlet showing a bad ground on outlet tester, also needs to be upgraded to GFCI outlet.

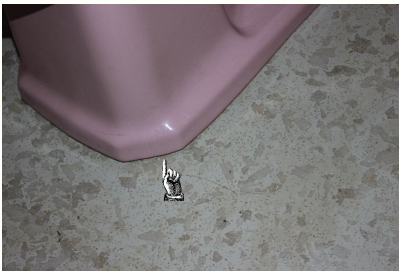
Caulking can be added around the base of the toilet to help prevent moisture penetration to the sub floor.

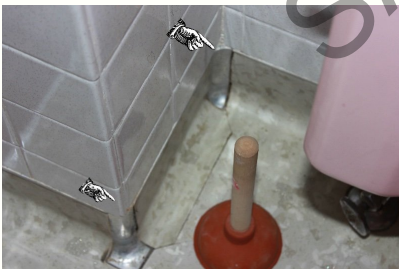
These areas should be checked and caulked as necessary, as well as any other gaps in the floor and kick plates.

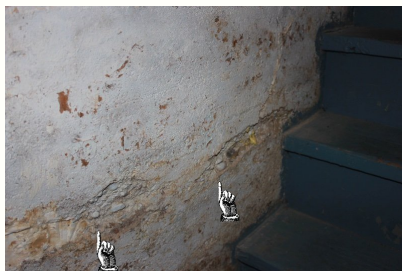
This crack in the east wall should be monitored moving forward.

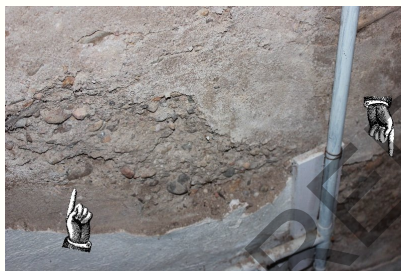
Continuation of the crack.

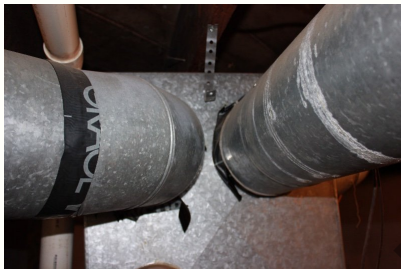
The sealant tape is begging to pull loose from the joints around the furnace and ductwork.

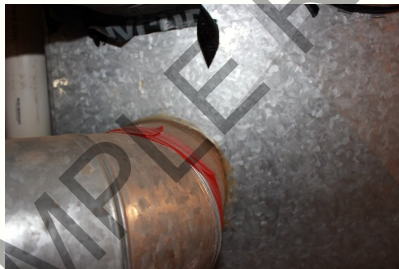
The red tape in this picture is not of the type typically used to seal duct joints.

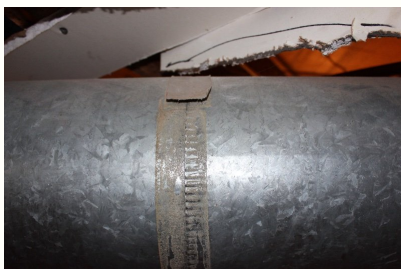
Another joint that needs repaired with new tape.

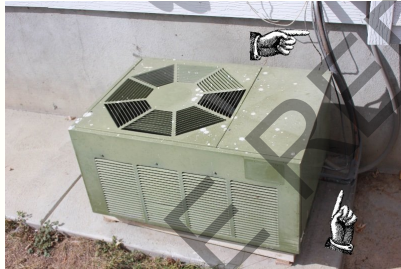
The supply and return lines need new insulation wrap.
