Sherlock Homes Inspection & Appraisal, LLC

Rick Moore
2760 Bridle Dr.
Mead, CO 80542

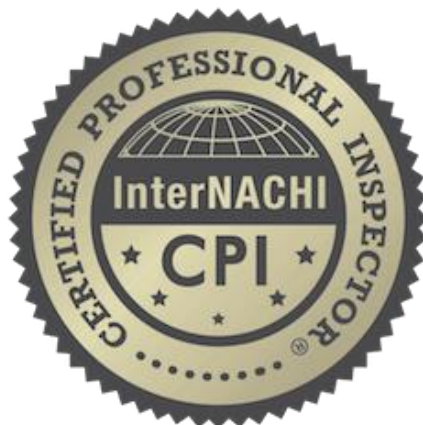
Email: rickmoore096@gmail.com
Phone: 970-481-7977
Web: sherlockhomesco.com

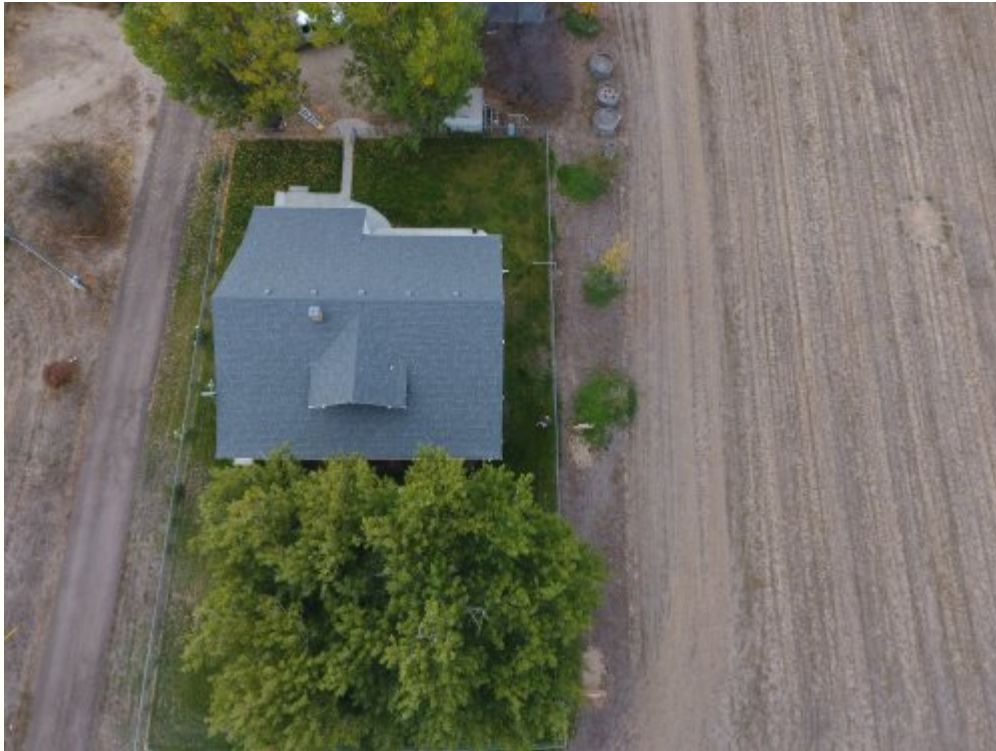
This report is solely for the benefit of the Client. Any person or party designated by the Client to receive information in this report shall be subject to the TERMS AND CONDITIONS contained herein. Such designation shall be provided in writing to the inspector.

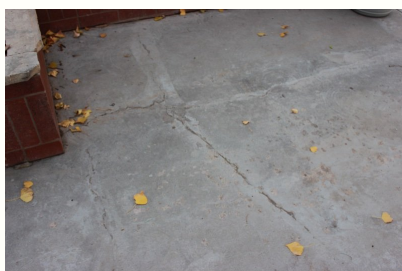
There are some minor cracks in the concrete to be expected in Colorado. The sidewalks is functioning as intended and no concerns or issues were noted.

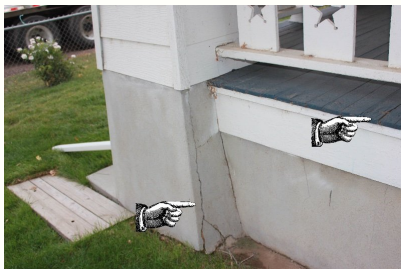
Cracking in front porch column. Wood deterioration on front porch decking.

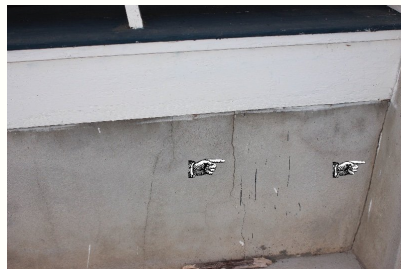
Cracks in front supporting wall, and separation crack in column.

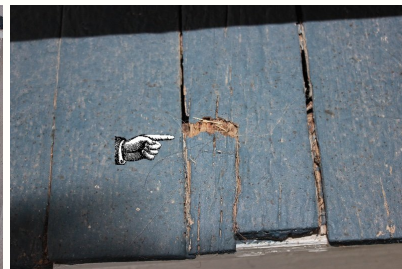
Wood deterioration on front porch.

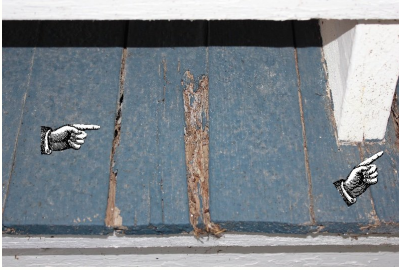
Wood deterioration on front porch decking.

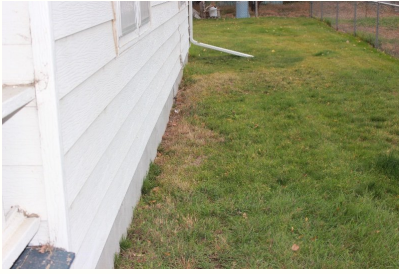
This is the west side of the home. The grade slopes towards the foundation and there is a small trough area next to the foundation that can pool water.

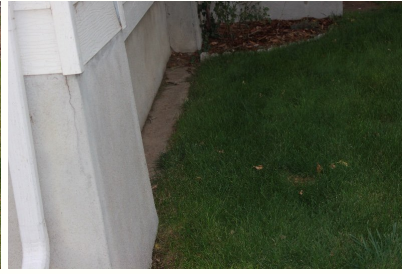
Negative grade at front porch supporting wall.

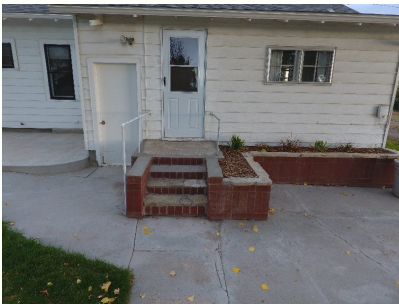
The back steps have been partially finished with a natural stone cap. The top step, the landing, and the wall caps on the side of the steps have not been finished with the same product. One possible upgrade in the future would be to finish out these area with the same stone cap. A licensed contractor should be consulted for further evaluation and costs.

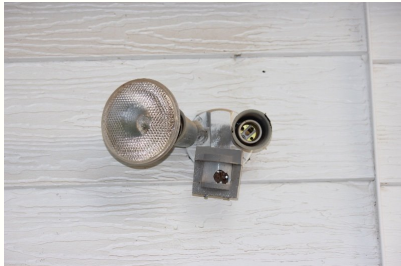
This light is missing a bulb and it appears the motion sensor may be broken. A licensed contractor should be consulted for repair or replacement.

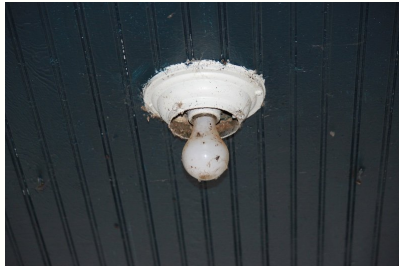
This light is located on the front porch and should have a proper weather protective globe cover installed on it.

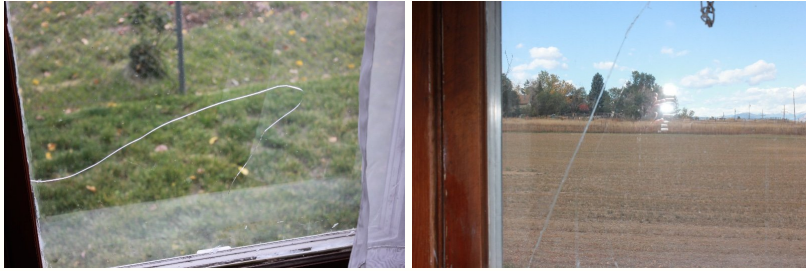
further evaluation and pricing.

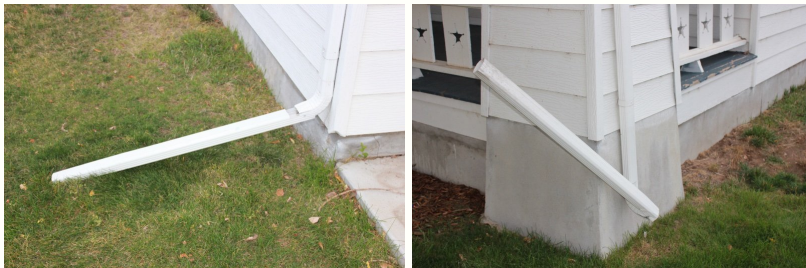
Downspout extension should be extended out further to a minimum of 6' or more from the foundation.

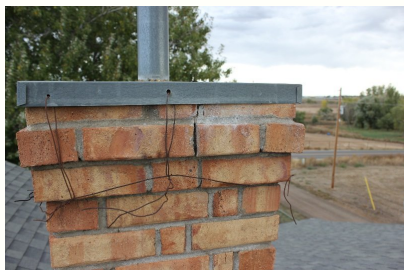
Rain cap improperly secured to chimney. Mortar failure and cracking in the brick joints.

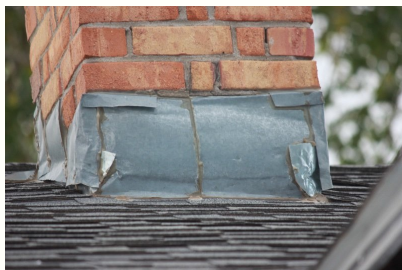
Improperly installed flashing at base of chimney on roof.

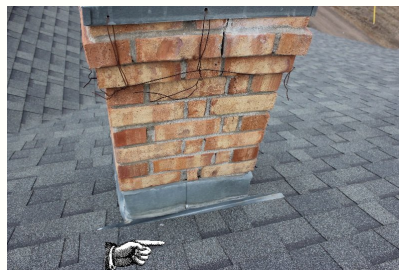
This side of the chimney should have cricket flashing installed to divert the water around the structure.

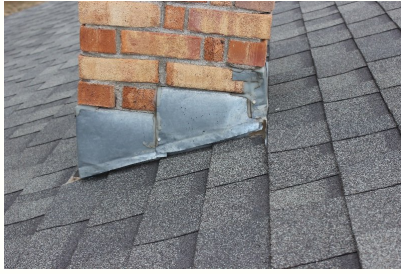
Improperly installed step flashing.

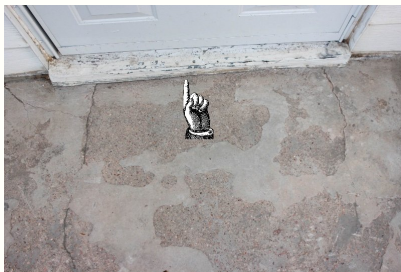
Wood deterioration on back door leading to the main floor.

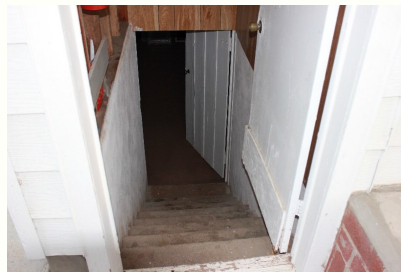
Basement access door from the backyard improperly opens over the stairs. This is a safety hazard and the door needs to be reversed to swing outwards. The door is not designed for exterior use and thus is deteriorating and should be replaced at the same time.

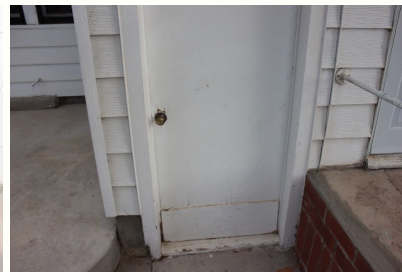
Exterior door leading to the basement from the backyard. Showing signs of water damage and deterioration.

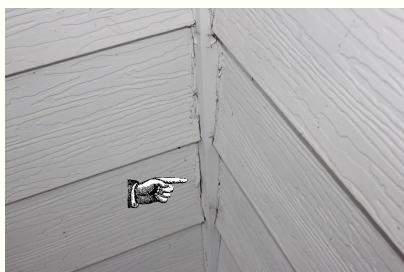
Some minor caulking maintenance is needed around the joints of the siding and trim by a licensed contractor.

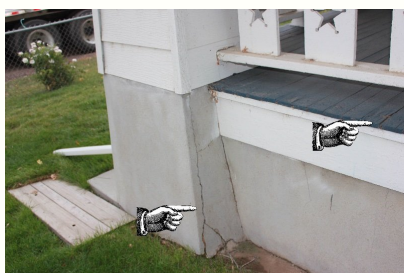
Cracking in column may be superficial or structural, there is no way to tell from a visual inspection.

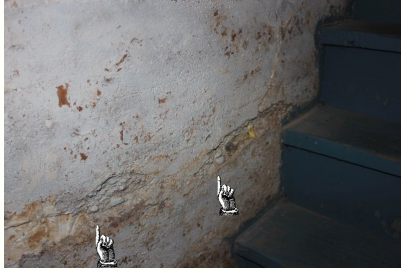
Vertical crack in foundation most likely caused by water penetration and negative grade to the outside wall. The sidewalk in this area has been replaced recently and the grade issue has been corrected.

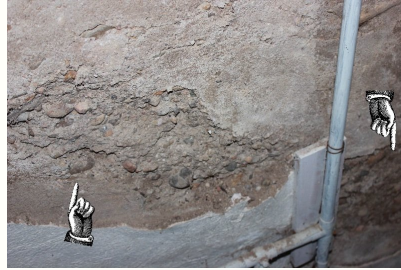
Vertical crack continues into the main room of the basement.

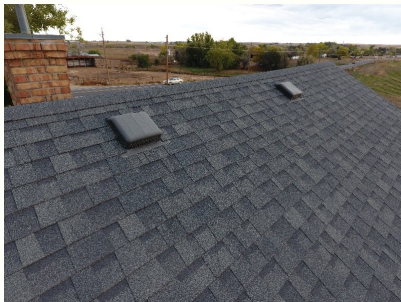
roof shingles and vents on the south back side of the home.

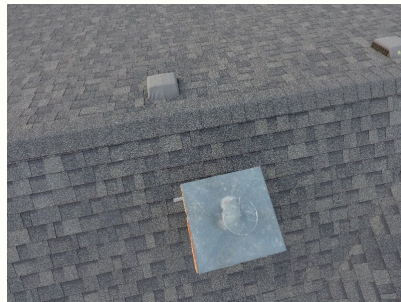
roof shingles from drone picture, viewing above chimney and peak of roof.

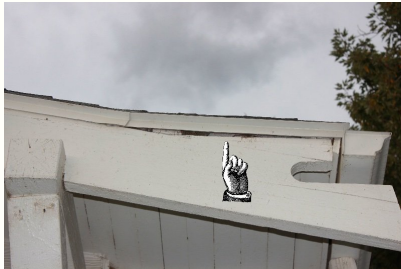
Flashing should properly extend over this gap and sufficiently onto the 2"x8" outer roof rafter below it.

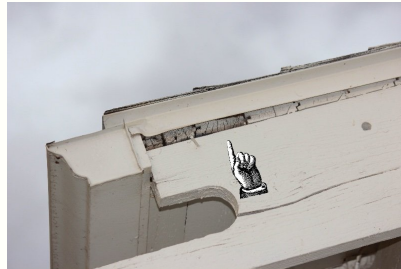
Improperly installed flashing, the flashing length is not sufficient to cover the gap, thus allowing water penetration.

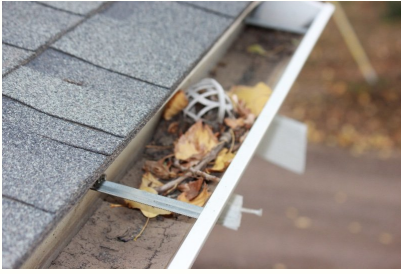
Debris and sediment build up in the gutters on the roof.

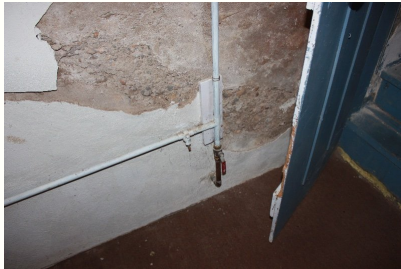
Water entrance and interior supply shut off in the basement on the east.

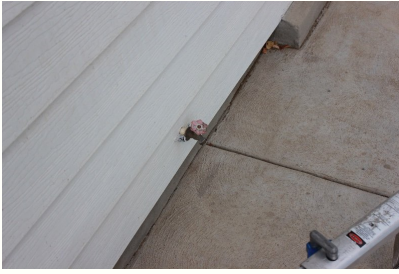
Outdated hose bib, a splash pan should be installed underneath this bib to help move water away from the foundation while it is in use.

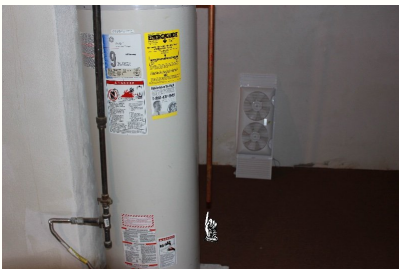
Improper termination of TPR relief valve drain pipe.

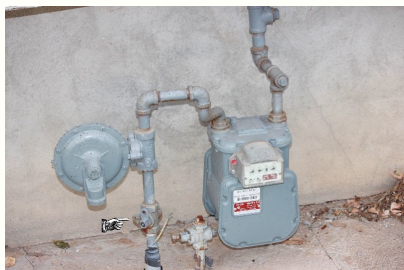
The gas meter was inspected and appeared in normal condition, no concerns or issues were noted. The supply shut off is located on the down leg of the meter and pointed out in the picture.

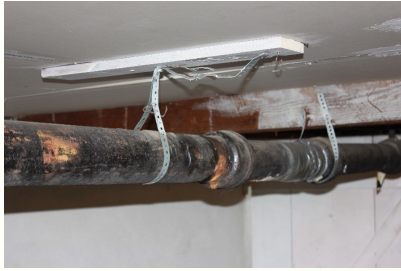
Improperly supported cast iron drain pipes.

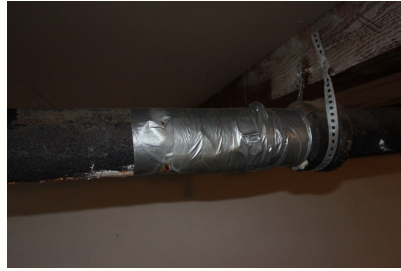
This pipe appears to have an improper repair to it, and is not properly supported.

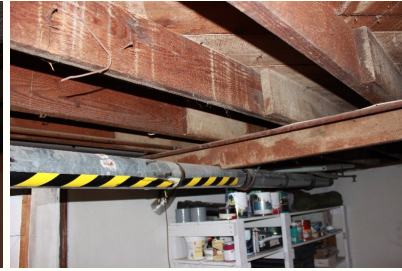
These sections of the drain waste pipe appear to have been improperly repaired with sheet metal duct pipes and sealant.

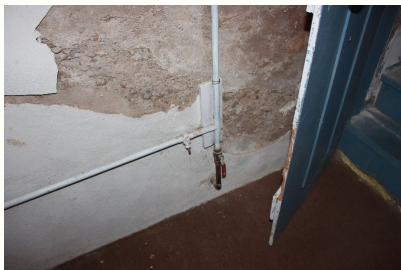
Water entrance and interior supply shut off valve.

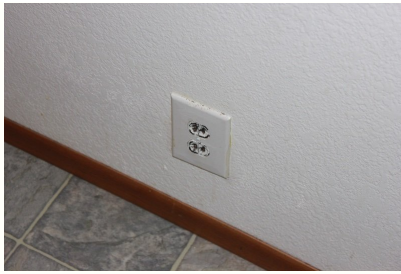
Electrical Outlet in master bathroom needs removed or upgraded to GFCI receptacle.

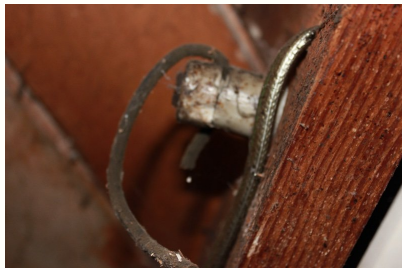
What appears to be abandoned Knob & Tube wiring in the basement rafters.

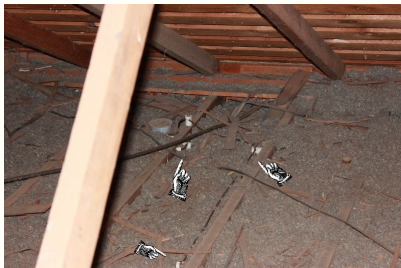
Antiquated knob and tube wiring improperly installed. This is a serious concern and should be examined and upgraded by a licensed electrician as soon as possible.

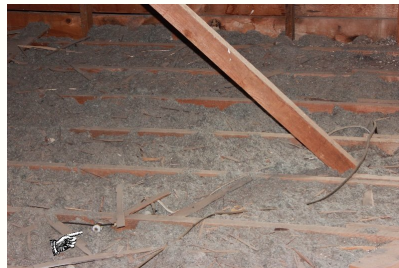
More knob and tube wiring improperly installed in the attic.

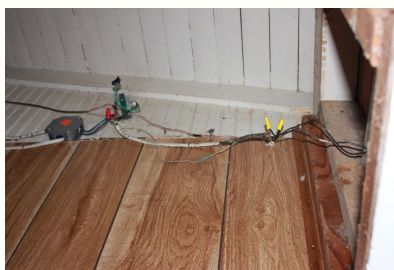
Branch circuit wiring splice not properly contained within an approved and covered box.

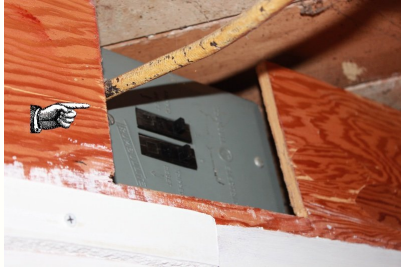
This sub-panel located in the basement rafters is not in a proper location.

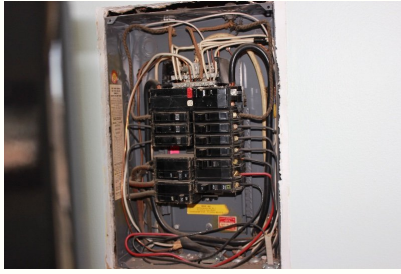
Main electrical panel in the kitchen.

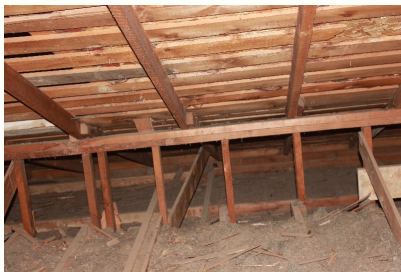
Attic roof sheathing and rafters.

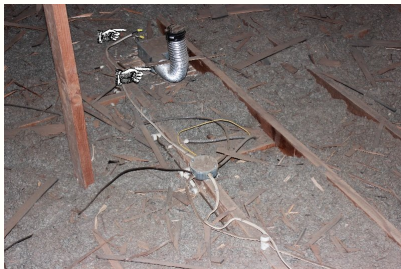
Improper termination of bathroom fan, wiring splice is not properly contained in an approved covered box.

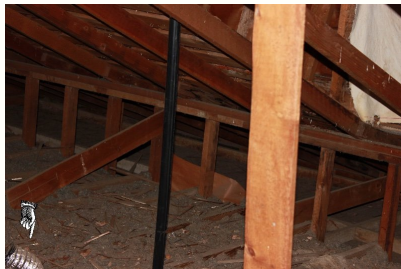
Improper termination of bathroom vent in attic.

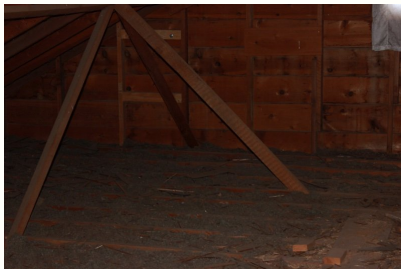
These roof supports should be checked and verified by a structural engineer as properly installed.

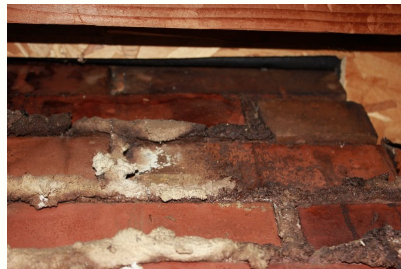
mortar joints on chimney stack in the attic showing deterioration. efflorescence is also present indicating past water damage.

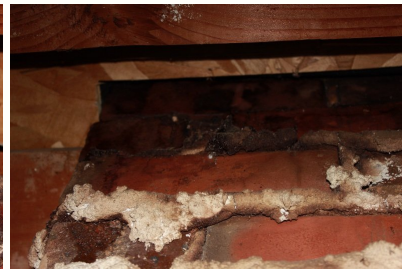
Brick chimney stack in attic showing improper repair to deteriorating mortar joints.

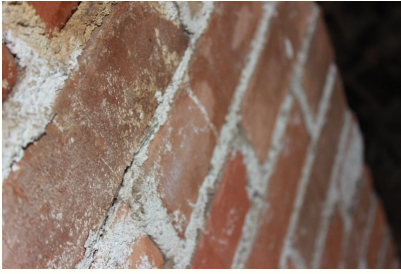
Chimney stack with deteriorating and improperly repaired mortar joints.

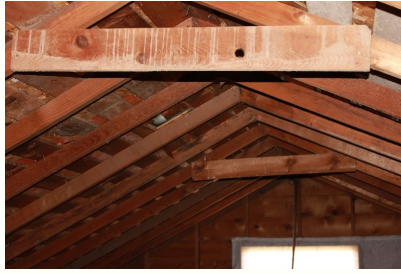
Roof frame showing OSB sheathing over former roof battens, supported by 2"x6" roof rafters. Two collar beams can also be seen adding support to the rafters.

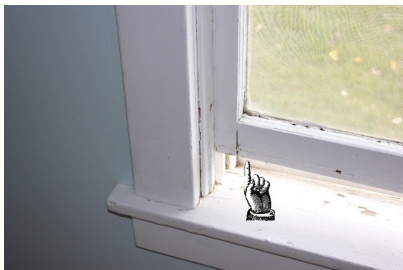
Wood deterioration can be observed on the sash of this window.

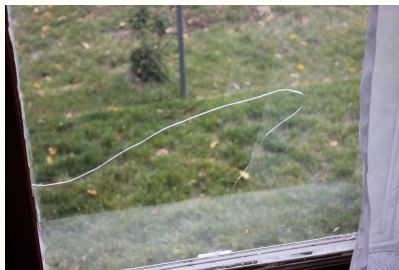
One of two broken window panes observed.

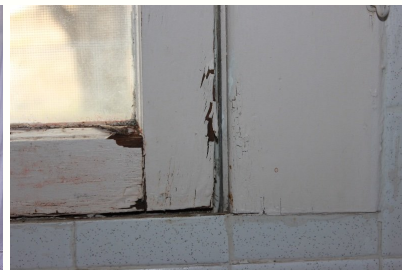
The wood on the sash of this bathroom window is rotting from excessive water penetration.

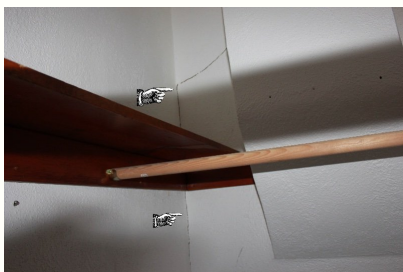
It is possible that the chimney stack encased in this wall is failing and causing this crack.

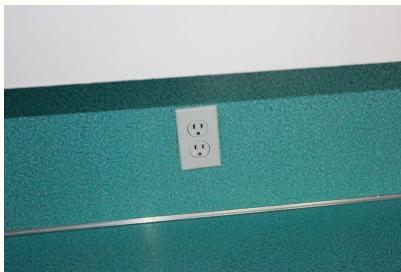
Non GFCI outlet in the kitchen.

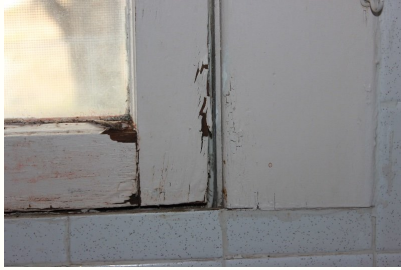
Water damage to the window sash and frame.

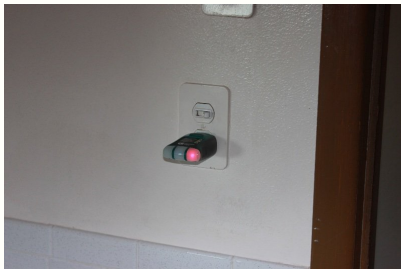
Electrical outlet showing a bad ground on outlet tester, also needs to be upgraded to GFCI outlet.

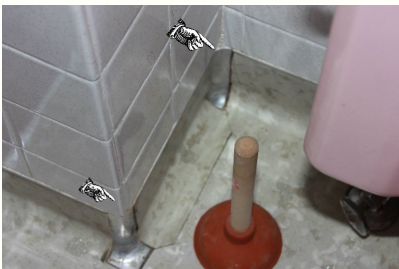
These areas should be checked and caulked as necessary, as well as any other gaps in the floor and kick plates.

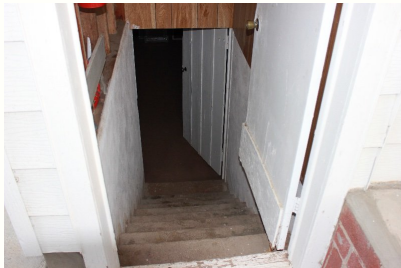
The entry stairway to the basement from the the backyard is not properly lighted nor does it have a handrail. A licensed contractor should be consulted for further evaluation.

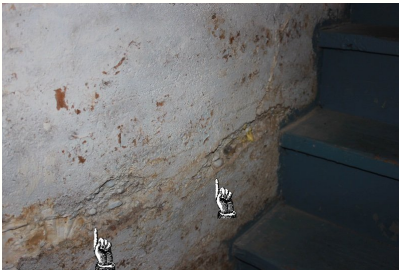
This crack in the east wall should be monitored moving forward.

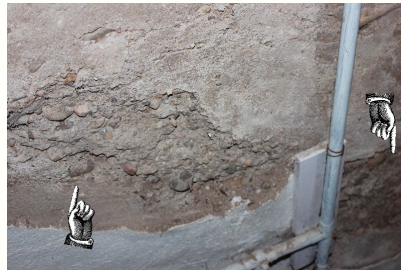
Continuation of the crack.

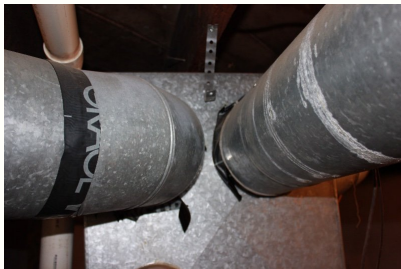
The sealant tape is begging to pull lose from the joints around the furnace and ductwork.

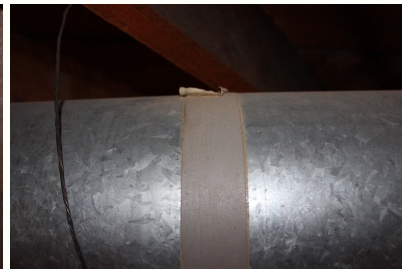
The old tape on this duct joint has deteriorated and needs removed and replaced.

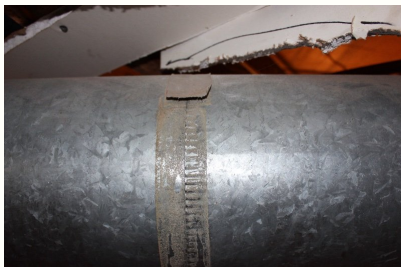
Another joint that needs repaired with new tape.

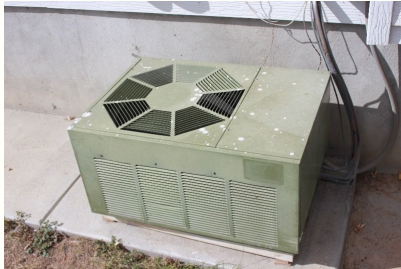
Existing central air unit.

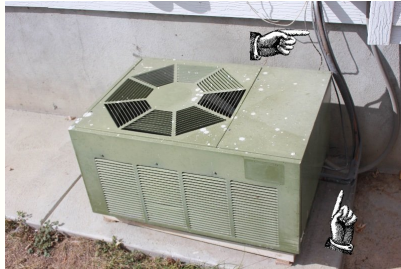
The supply and return lines need new insulation wrap.
