# *Sherlock Homes Inspection & Appraisal, LLC*

## Property Inspection Report

1234 Inspection Blvd, Mead, CO 80542  
Inspection prepared for: John Doe & Jane Doe  
Real Estate Agent: Jimmy Doe - Resident Realty

Date of Inspection: 1/26/2017 Time: 11:00 a.m.  
Age of Home: 8 months Size: 4865 sq. ft.  
Weather: Cloudy

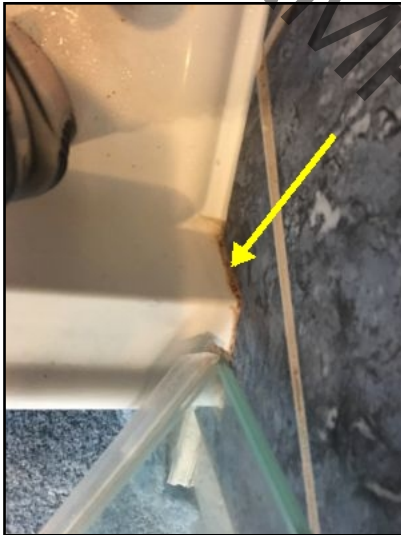
14. Showers

Some mildew can be seen in this corner and should be easily cleaned out.

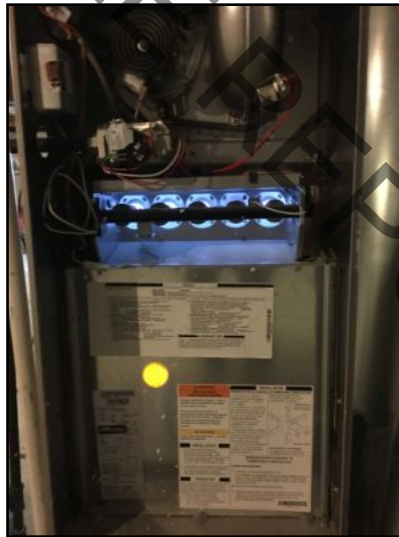
Furnace ignited correctly and ran as intended with a nice crisp blue flame.

- Fuel Furnace: Last service date is unable to be determined, I would recommend speaking to the current home owner about service schedules. Although this unit appears to be operating properly from controls, there are areas which cannot be seen without specialized equipment and training. One such area is the combustion chamber / heat exchanger where cold air blows across the "fire box", becoming the hot air that circulates throughout your home. During the life span of any furnace, this metal wall may develop a crack or a broken weld, allowing carbon monoxide to circulate throughout the home. This is why furnace specialists recommend a complete inspection annually; consider having unit inspected by certified HVAC technician.

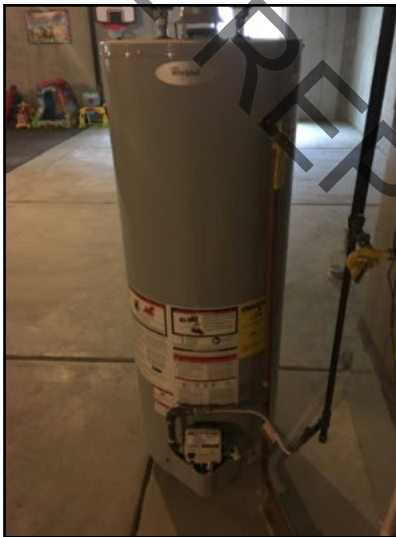
Heater Type: Gas  
 Location: The heater is located in the basement.  
 Observations:  
 • Tank appears to be in satisfactory condition -- no concerns.  
 • No major system safety or function concerns noted at time of inspection.

How water heater

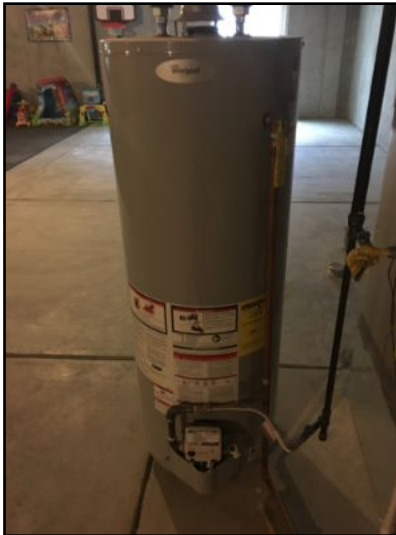
#### 6. TPRV

Observations:  
 • Appears to be in satisfactory condition and is plumbed correctly to the floor drain -- no concerns.

TPR valve is correctly installed and plumbed to the floor drain.

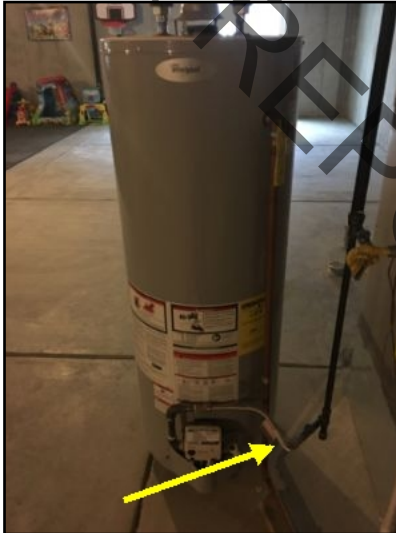
The water heater appears in good condition. Gas feed shut off is located at yellow arrow.

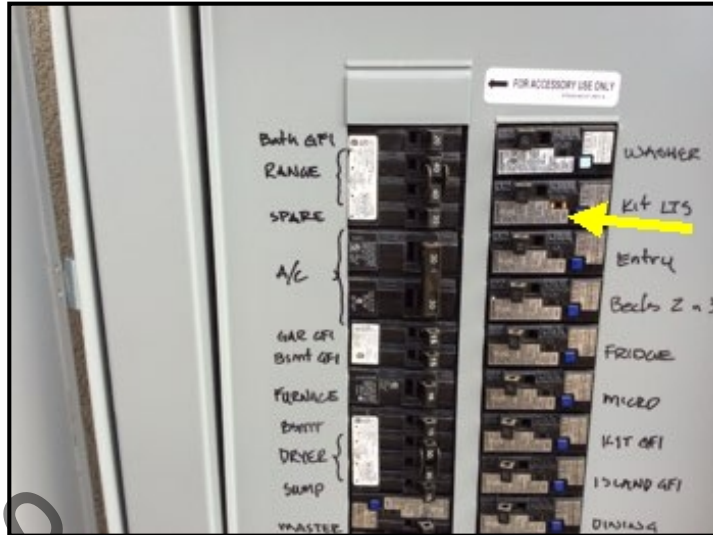
- 1
- **There is one breaker that the ground fault has thrown. I would recommend speaking with the current home owner an asking him to reset it. If it continues to fault a licensed electrician should be consulted for further evaluation.**

Breakers all properly labeled with the main electrical shut off just above .

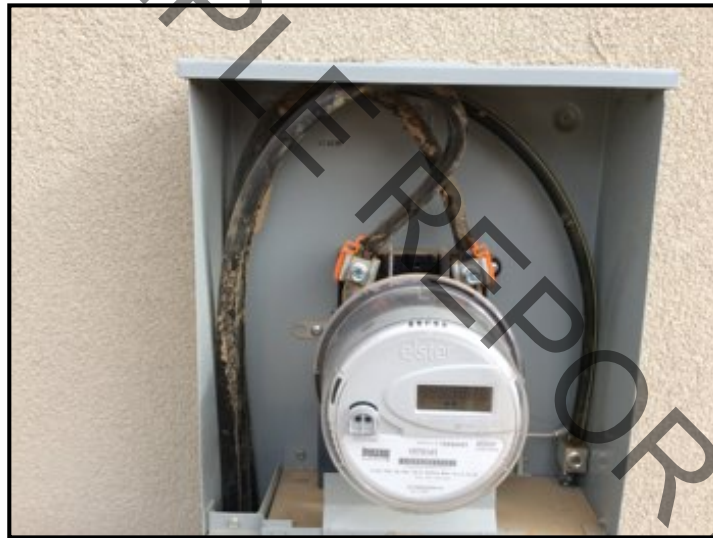
4. Cable Feeds

Main cable feeds are #2/0 aluminum wire properly connected. Aluminum wiring connections should be inspected by a licensed electrician every 3-5 years.

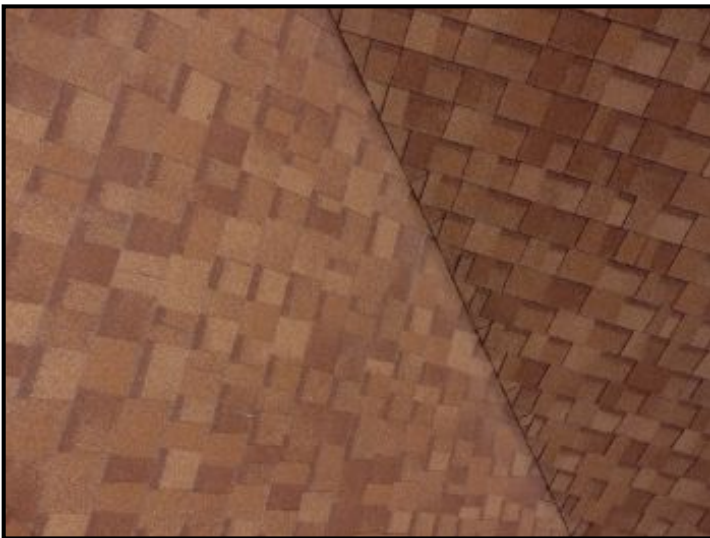
Covered valley on roof properly over lapped.

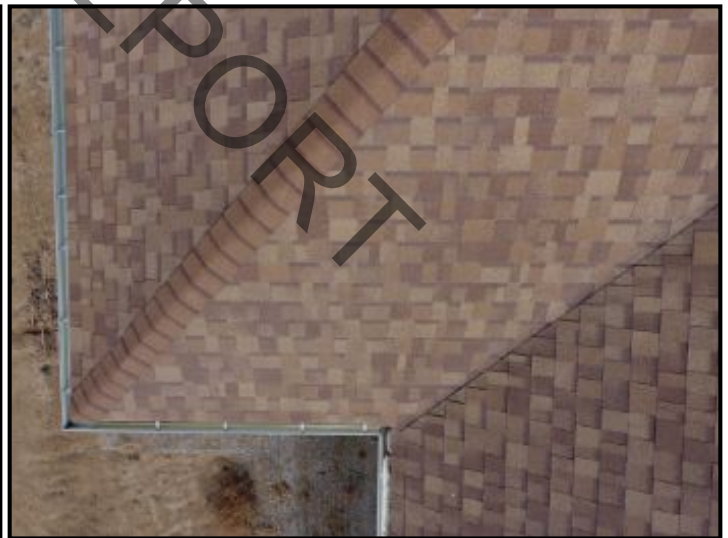
- No major system safety or function concerns noted at time of inspection.
- The hip above the garage is wavy as it rises towards the ridge. It is the inspectors opinion that this is primarily due to poor instalation of the ridge caps and poor framing / blocking beneath. I do not believe this is a safety issue, I would recommend monitoring this area moving forward.

Ridge Caps on hip

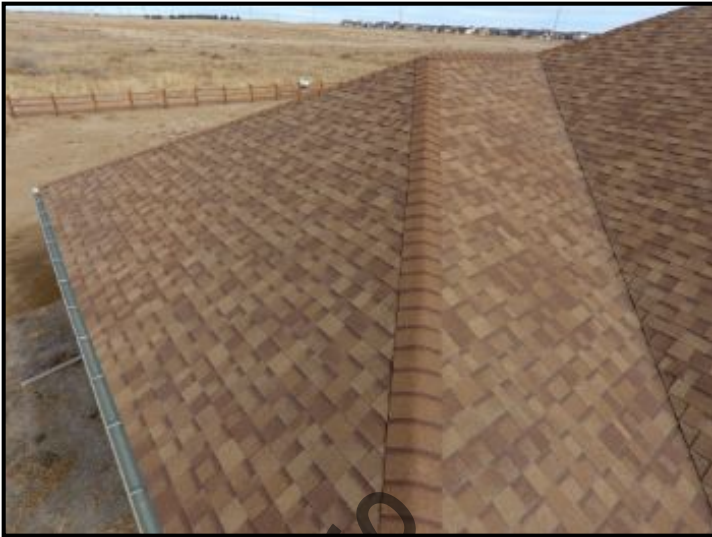
Ridge caps on hip

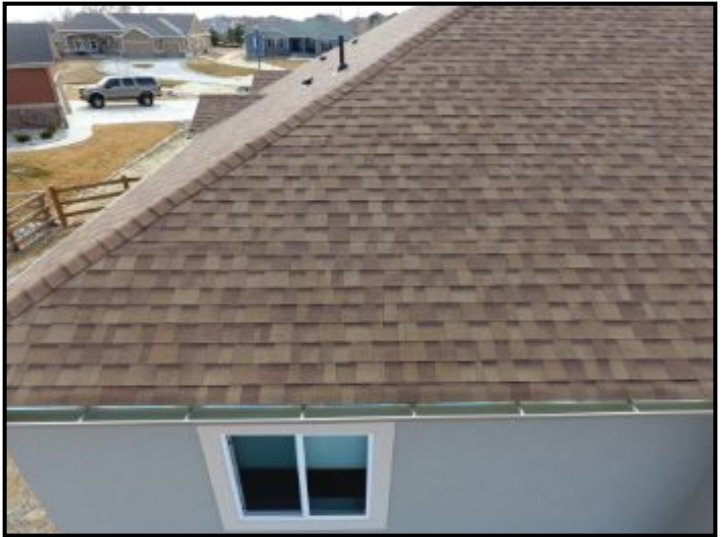
Aerial of hip and shingles on roof

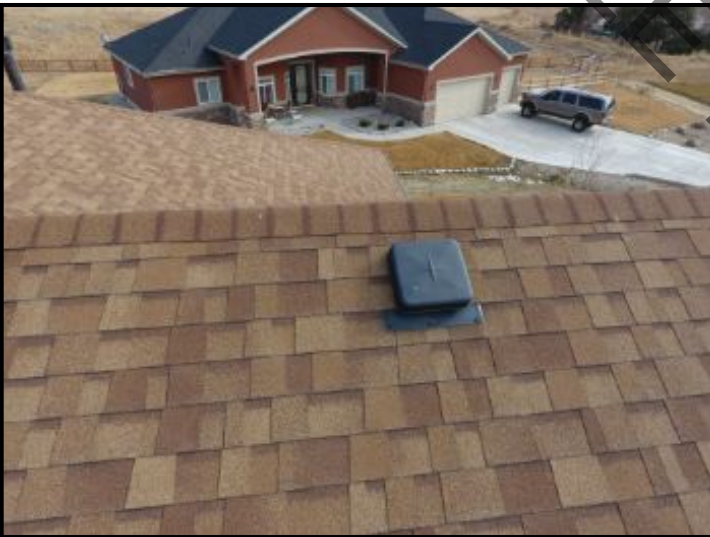
Attic turtle vent properly installed.

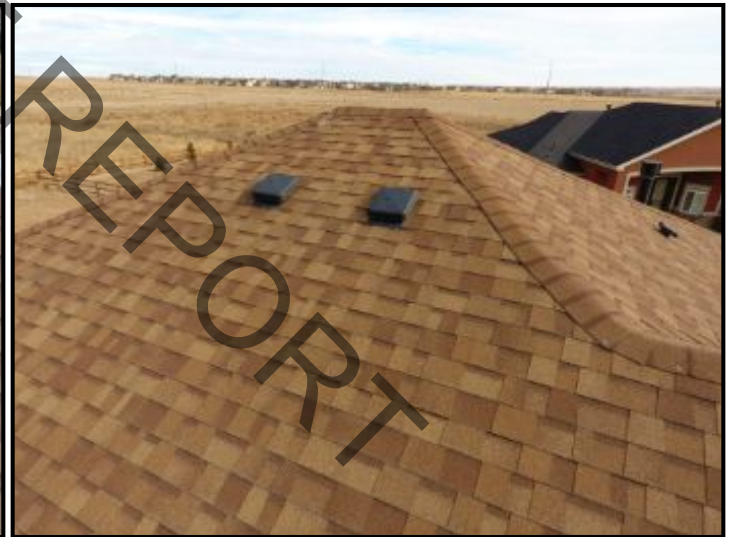
Observations:  
 • The vent caps were inspected with drone and all appeared in satisfactory condition.

Turtle vent caps properly installed.

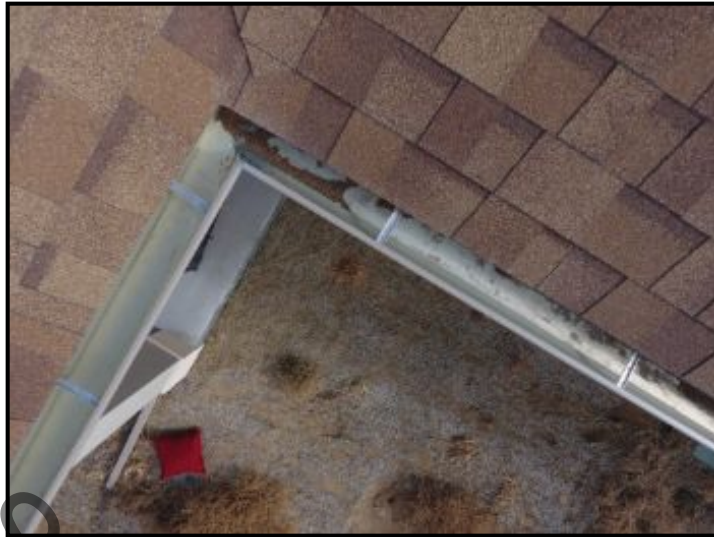
### 7. Gutter

The gutters on the structure are in excellent shape and functioning as intended.

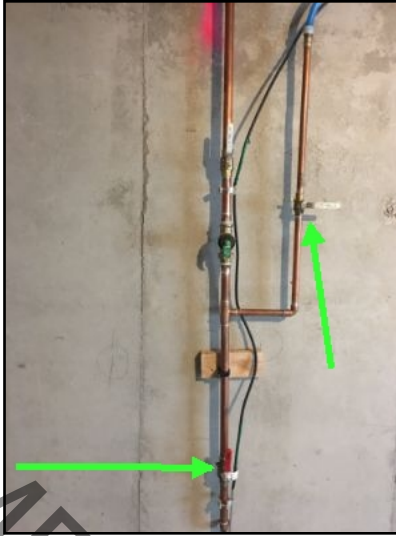
Water entrance showing the main shut off for the house as well as the shut off and winterization drain for the irrigation system.

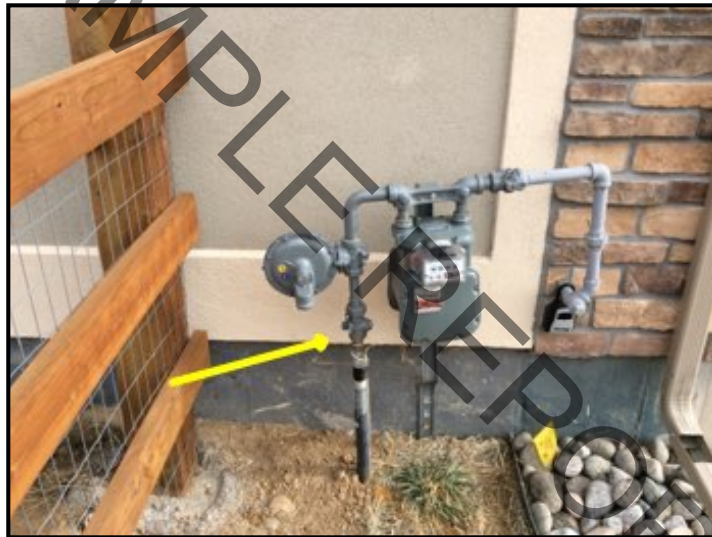
The gas meter is on the west side and the main shut off for the house is located at the yellow arrow.
