## **Sherlock Homes Inspection & Appraisal, LLC**

1234 ABC Lane  
Denver CO 80202

# Summary

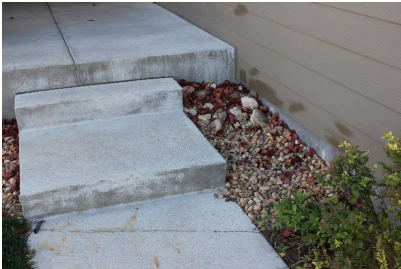
The steps were inspected with no issues or concerns noted.

Front steps to the front door and porch.  
Please also see sidewalks for further comments.

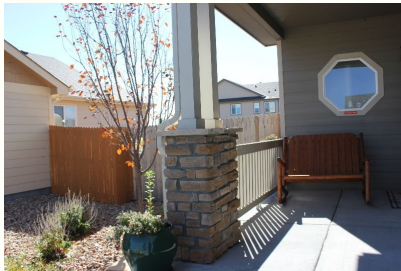
The front porch was inspected with no major issues or concerns noted. There was a settling crack on the top of the porch that should be monitored going forward. The wood columns that rest on the natural stone cap should be capped at the bottom of the wood column and the top of the stone cap intersection to prevent water penetration.

Front porch showing concrete deck, stone / wood column, and wood railing.

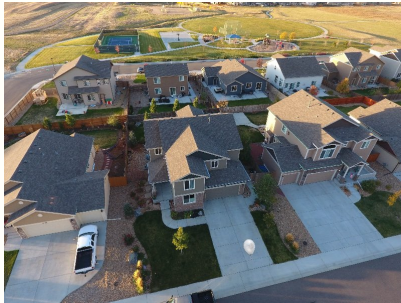
This home was completed in December of 2012. The builder was St. Aubyn Homes.

Aerial photo of the home and the park.

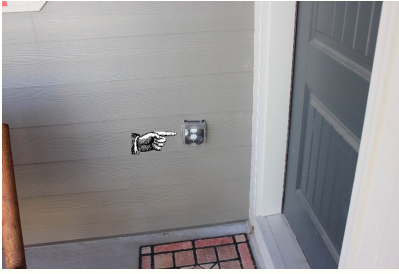
The exterior receptacles were inspected and appear to be properly installed with GFCI protection. The GFCI was tested and worked as intended.

110 receptacle at front door is properly connected to a GFCI and covered by a weather plate.

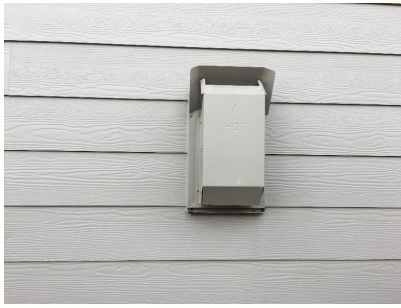
There are two metal flues on the home that vent the gas fireplace in the living room on the west side of the home, and the master bedroom fireplace on the second floor south side of the home. Both flues were inspected and no issues or concerns were noted.

Metal flue for living room gas fireplace on the east side of the home.

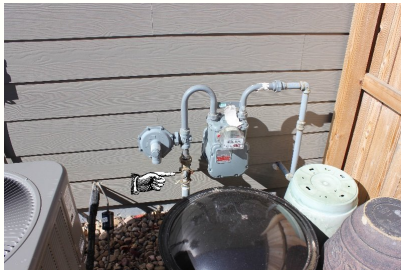
The gas meter is located in the back yard on the east side of the home. The main shut off for the house is located here on the up leg of the meter. During the inspection no issues or concerns were noted.

Gas meter located in the back yard on the east side. The hand in the picture is pointing at the main shut off valve for the house.

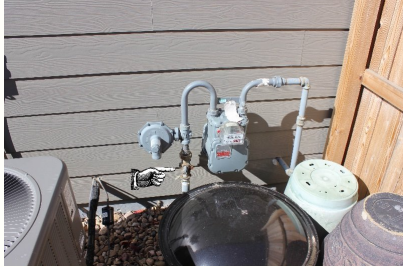
Gas meter, the finger points to the main shut off for the house.

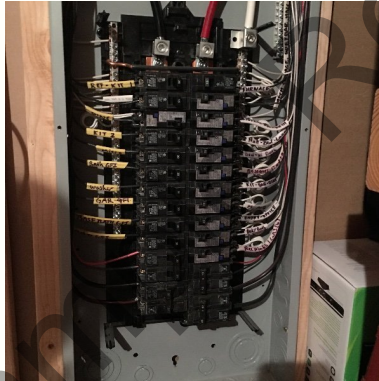
Circuit breakers and wiring. Wiring is copper rolex wiring except for the feeds, and 240 circuits. These circuits are aluminum and appear to be properly connected.

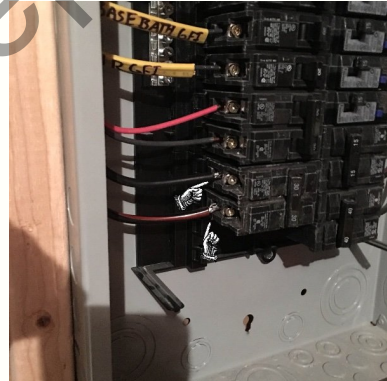
Aluminum wiring on the 240 circuits. It is properly cold welded and attached to aluminum lugs.

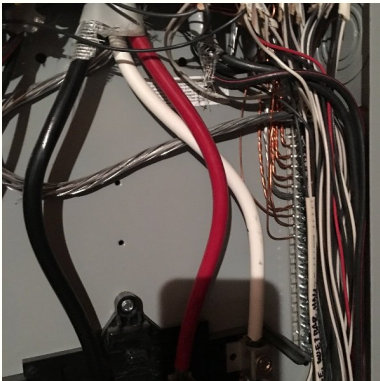
proper bonding for the electrical system in the home.

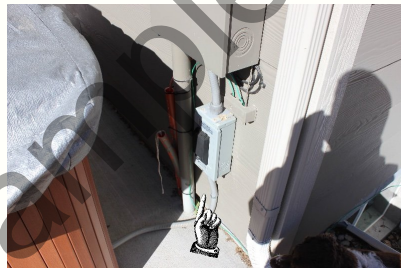
Finger points at sub panel for the hot tub with a 50 amp GFCI circuit breaker.

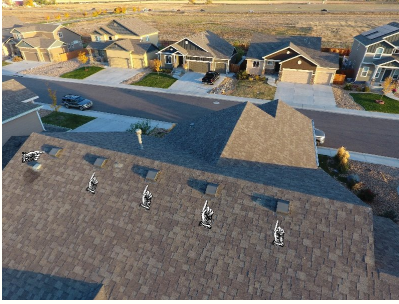
The ridge vents were inspected with a drone, and from inside the attic. No issues or concerns were noted at the time of the inspection.

Drone picture of roof, fingers pointing at the ridge vents for the attic.

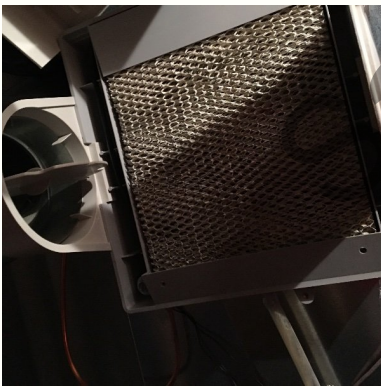
The humidifier was inspected and operated and it was functioning as intended at the time of this inspection.

humidifier with service panel removed.

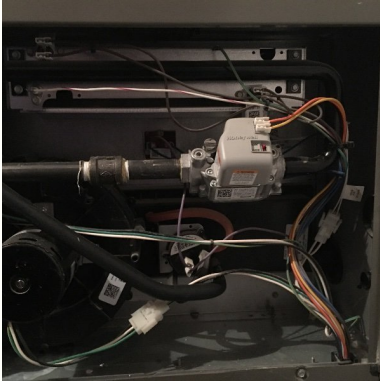
The gas furnace was inspected and operated. At the time of inspection the furnace was operating as intended and there were no issues or concerns noted.

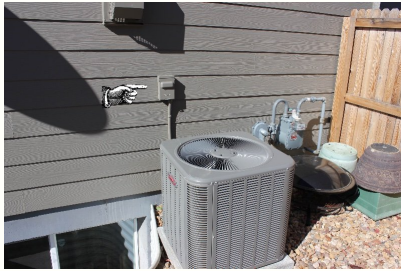
There are two disconnects, a pull out fuse located on the outside wall right behind the unit. A separate breaker is also located in the sub panel in the basement and is properly labeled.

AC unit with the electrical disconnect on the wall right behind.
