Sherlock Homes Inspection & Appraisal, LLC

1234 ABC Lane
Denver CO 80202

Summary

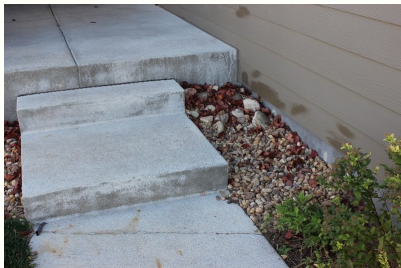
The steps were inspected with no issues or concerns noted.

Front steps to the front door and porch.
Please also see sidewalks for further comments.

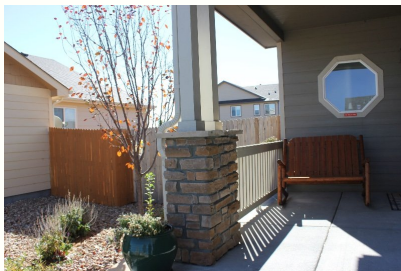
The front porch was inspected with no major issues or concerns noted. There was a settling crack on the top of the porch that should be monitored going forward. The wood columns that rest on the natural stone cap should be capped at the bottom of the wood column and the top of the stone cap intersection to prevent water penetration.

Front porch showing concrete deck, stone / wood column, and wood railing.

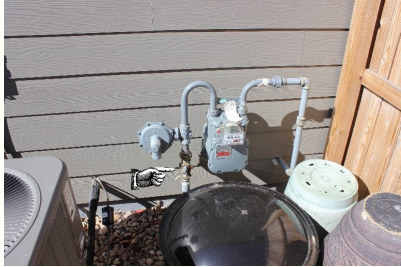
Gas meter, the finger points to the main shut off for the house.

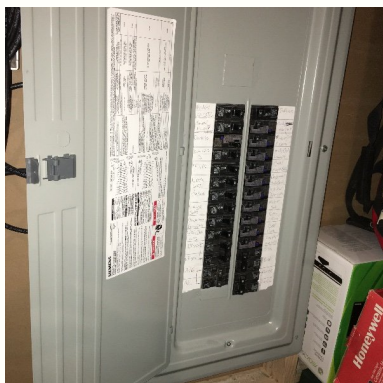
The space in front of the panel should be cleared for access.

Sub panel with all circuits labeled.

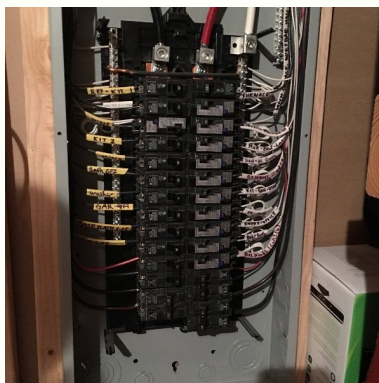
Circuit breakers and wiring. Wiring is copper rolex wiring except for the feeds, and 240 circuits. These circuits are aluminum and appear to be properly connected.

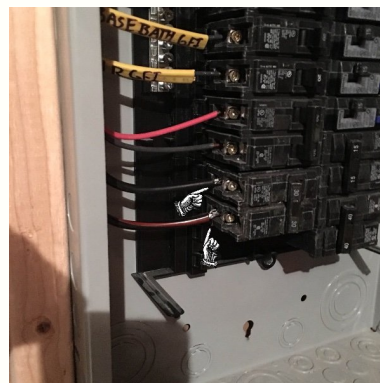
Aluminum wiring on the 240 circuits. It is properly cold welded and attached to aluminum lugs.

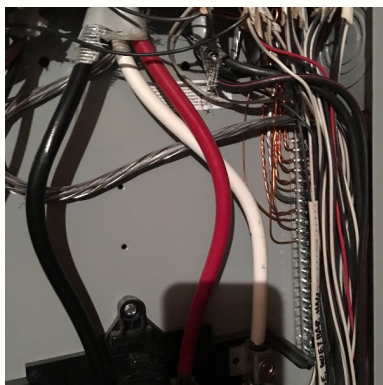
proper bonding for the electrical system in the home.

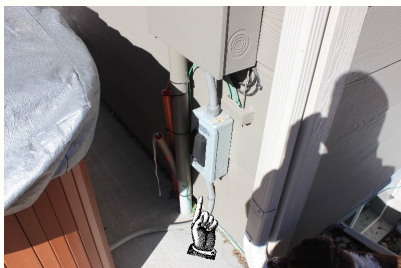
Finger points at sub panel for the hot tub with a 50 amp GFCI circuit breaker.

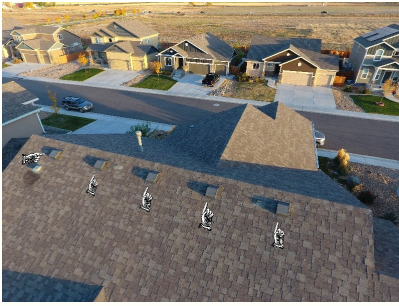
The ridge vents were inspected with a drone, and from inside the attic. No issues or concerns were noted at the time of the inspection.

Drone picture of roof, fingers pointing at the ridge vents for the attic.

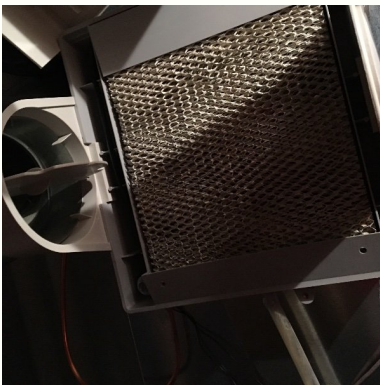
The humidifier was inspected and operated and it was functioning as intended at the time of this inspection.

humidifier with service panel removed.

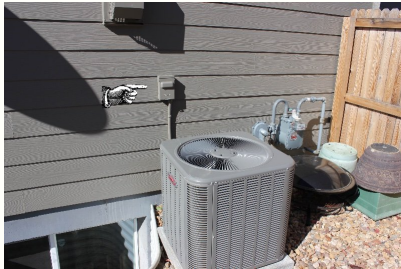
There are two disconnects, a pull out fuse located on the outside wall right behind the unit. A separate breaker is also located in the sub panel in the basement and is properly labeled.

AC unit with the electrical disconnect on the wall right behind.
