Sherlock Homes Inspection & Appraisal, LLC

John & Jane Smith
1234 ABC Lane
Denver, CO 80202
Phone: 303.555.5555

1234 ABC Lane
Denver CO 80202

Inspection Information

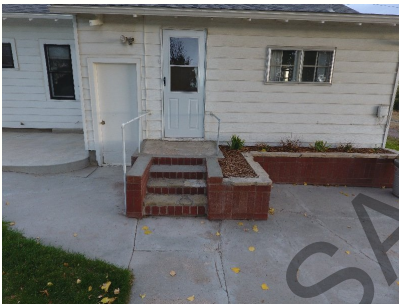
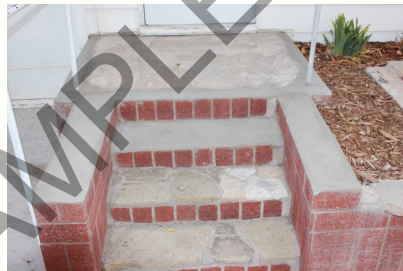
Back entry steps

The back steps have been partially finished with a natural stone cap. The top step, the landing, and the wall caps on the side of the steps have not been finished with the same product. One possible upgrade in the future would be to finish out these area with the same stone cap. A licensed contractor should be consulted for further evaluation and costs.

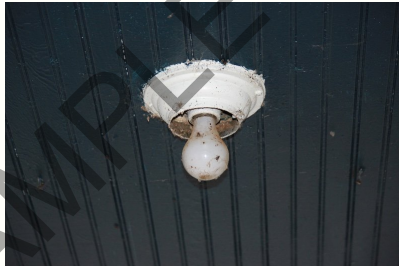
This light is located on the front porch and should have a proper weather protective globe cover installed on it.

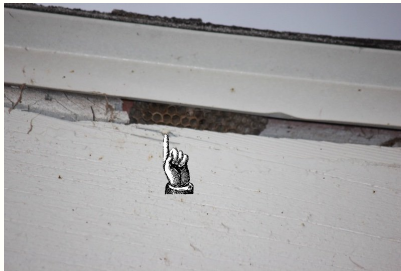
Wood eaves and soffits need some minor caulking. As well there were signs of wasp infestation in several areas. Wasp can be aggressive and a dangerous to people that have allergic reactions to stings. A licensed contractor should be contacted for further evaluation on pest removal.

Evidence of wasp infestation in the eave rake on the north east front of the home.

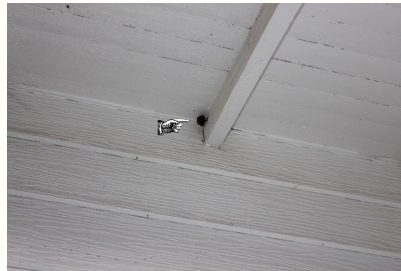
Wasp nest @ exterior wall and soffit corner.

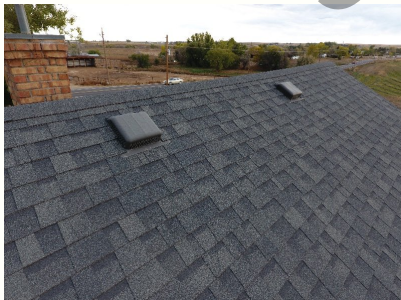
The roof shingles are 4-5 years old and appear in good condition.

roof shingles and vents on the south back side of the home.

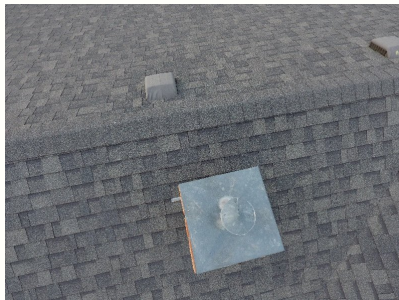
roof shingles from drone picture, viewing above chimney and peak of roof.

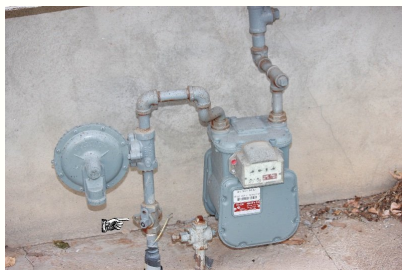
The gas meter was inspected and appeared in normal condition, no concerns or issues were noted. The supply shut off is located on the down leg of the meter and pointed out in the picture.

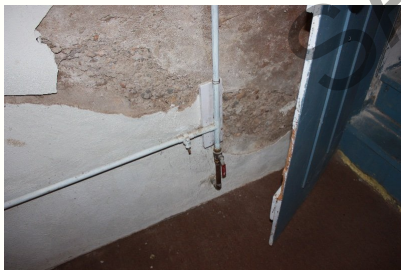
The water entrance was examined and no issues or concerns were noted. The supply shut off valve was inspected but not tested as this falls outside the scope of this inspection. The supply has been upgraded to copper at some point over the life of the house.

Water entrance and interior supply shut off valve.

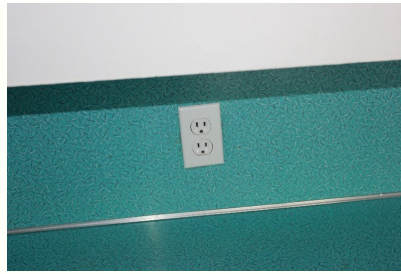
Electrical outlet in the kitchen needs upgraded to GFCI receptacle.

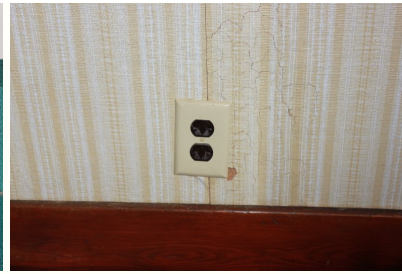
One of several outlets that is not properly grounded.

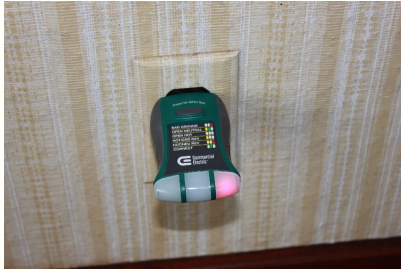
One of several outlets that has a bad ground.

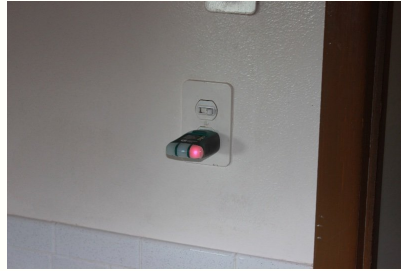
Electrical outlet in the hallway bathroom, bad ground and no GFCI.

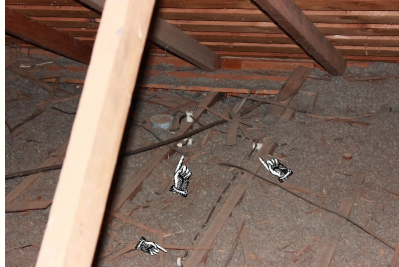
- As well Knob and Tube wiring was discovered in the attic on the floor laying in the insulation and appeared still in use. Knob and tube wiring branch circuits were found in the main panel still active as well. If these lines are still active this can be a serious fire hazard and needs to be **removed and upgraded immediately.**

Antiquated knob and tube wiring improperly installed. This is a serious concern and should be examined and upgraded by a licensed electrician as soon as possible.

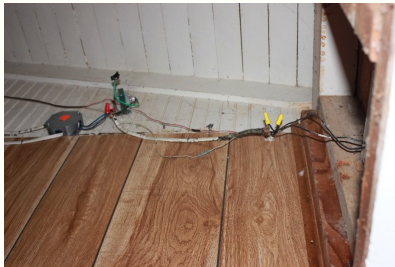
Branch circuit wiring splice not properly contained within an approved and covered box.

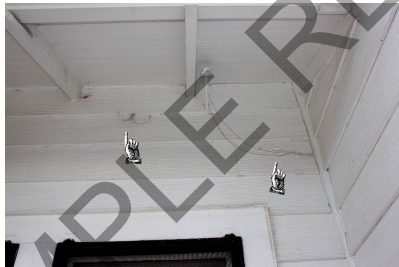
- Abandoned wires were found in the basement, outside, and in the attic. These wires should be checked and removed by a licensed electrician.

Wiring not properly installed within an approved box with cover, and abandoned wires.

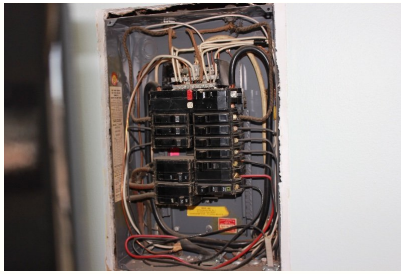
The main panel was inspected and no immediate concerns or issues were noted at the panel. There is a 30 amp breaker on the panel, this is not standard for residential wiring and may be an overused circuit. A licensed electrician should be consulted for further evaluation.

A wasp did crawl out of the panel during inspection. A licensed PMP (Pest Management Professional) should be contacted for further evaluation and correction.

Main electrical panel in the kitchen.

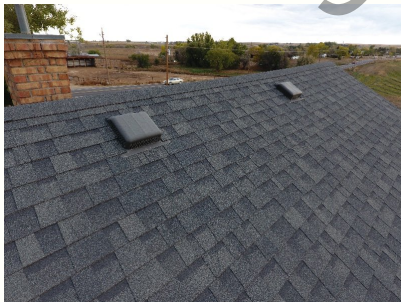
Ridge vents were installed with the new roof 4-5 years ago and appear to be providing adequate ventilation.

ridge vents in roofline.

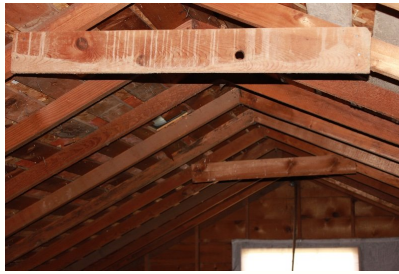
Roof frame showing OSB sheathing over former roof battens, supported by 2"x6" roof rafters. Two collar beams can also be seen adding support to the rafters.

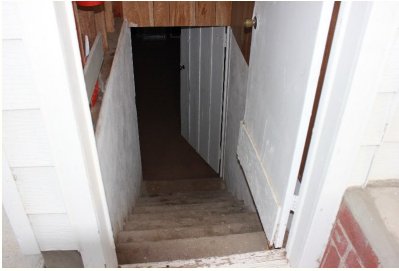
The stairway from the backyard to the basement does not have sufficient lighting nor a handrail. As well the door opens over the stairs without a proper landing and needs to be reversed to swing out instead of in. A

This stairway needs a railing, proper lighting and switches, and the door should not swing in over the stairs it should swing out for safety reasons.

licensed contractor should be consulted for further evaluation.

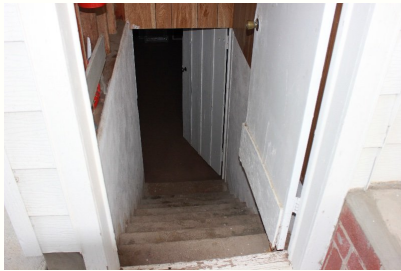
The entry stairway to the basement from the the backyard is not properly lighted nor does it have a handrail. A licensed contractor should be consulted for further evaluation.

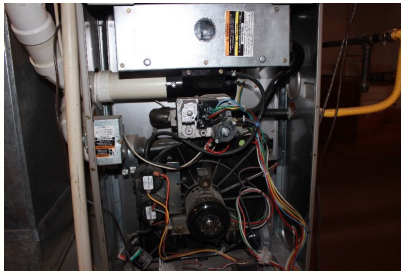
The gas furnace was not fully inspected as there was a technician servicing the unit at the time of inspection.

This is the gas furnace located in the basement with the maintenance panel removed.
